MiniSShot

Launch Report

Rev. 2010/08/15

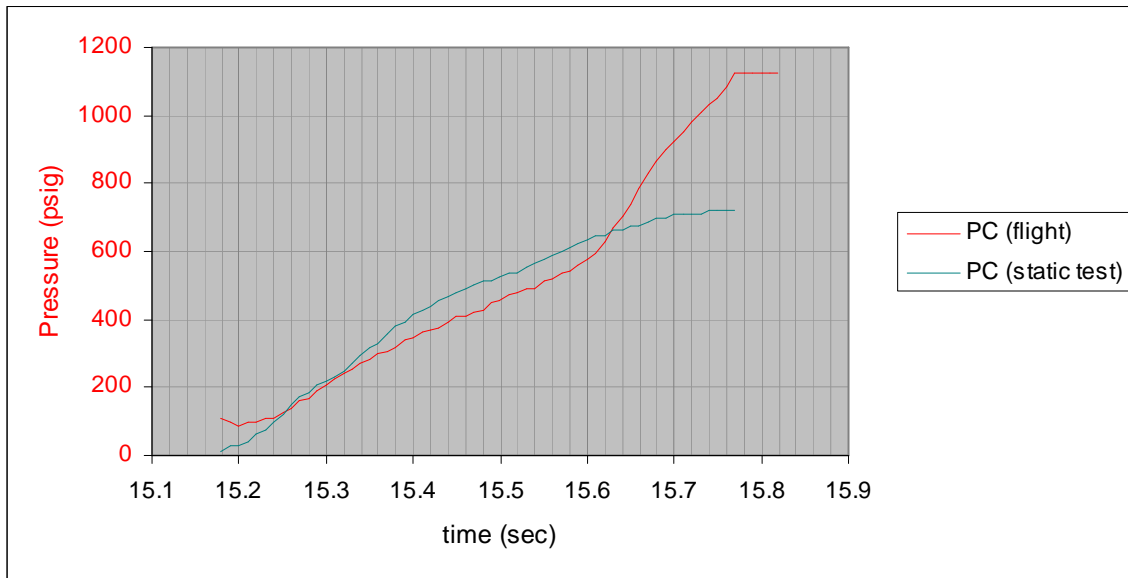
Figure 19 – Comparison between 2nd burn chamber pressure curves, flight versus static test

In Figure 19, a plot of chamber pressure versus time is shown for the 2nd burn. Superimposed is the corresponding plot of chamber pressure that is taken from the *ProtoSShot III* static firing (Ref.5). It is seen that both curves initially climb at a comparable rate. At the 15.61 second mark, a sudden change in slope is seen to occur in the flight curve. After that, the slope remains essentially constant until sensor saturation just prior to rupture.

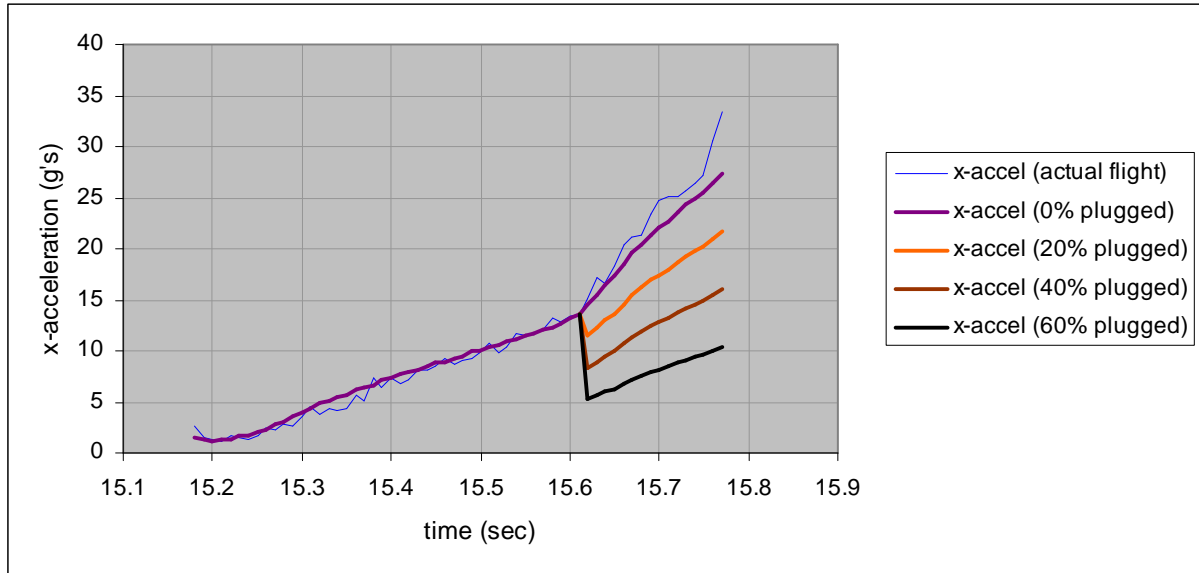
Figure 24 – Actual versus calculated acceleration based on restricted nozzle throat.

In Figure 24, the same analysis is presented, however, hypothetical blockage is assumed to suddenly occur at the 15.6 second mark, where the sharp change in slope begins. It is seen in the plot that a

distinct drop in acceleration would accompany such a hypothetical condition, which is contrary to the actual flight data. Based on this analysis, there is no evidence of nozzle blockage at any point during the 2nd burn. As final evidence, a frame-by-frame analysis of the on-board video footage clearly shows an ever-increasing amount of smoke emanating from the nozzle right up to the instant of rupture.

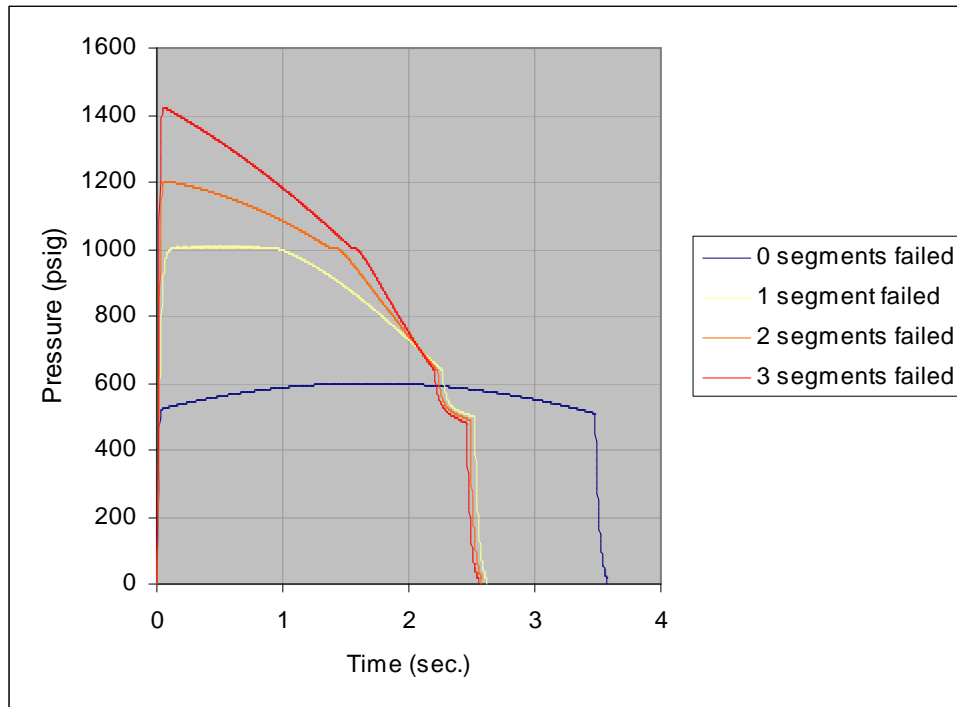
Figure 25 – Chamber pressure variation with fully-disbonded grain segments.

As can be seen, a complete casting tube failure of 3 grain segments would be necessary to develop chamber pressure high enough to account for the anomalous pressure level seen in flight. A post-flight dissection and detailed examination of the recovered forward casting tubes indicated that none were cracked or broken and suffered only the expected amount of thermal degradation based on the extended burn duration of the 2nd phase.

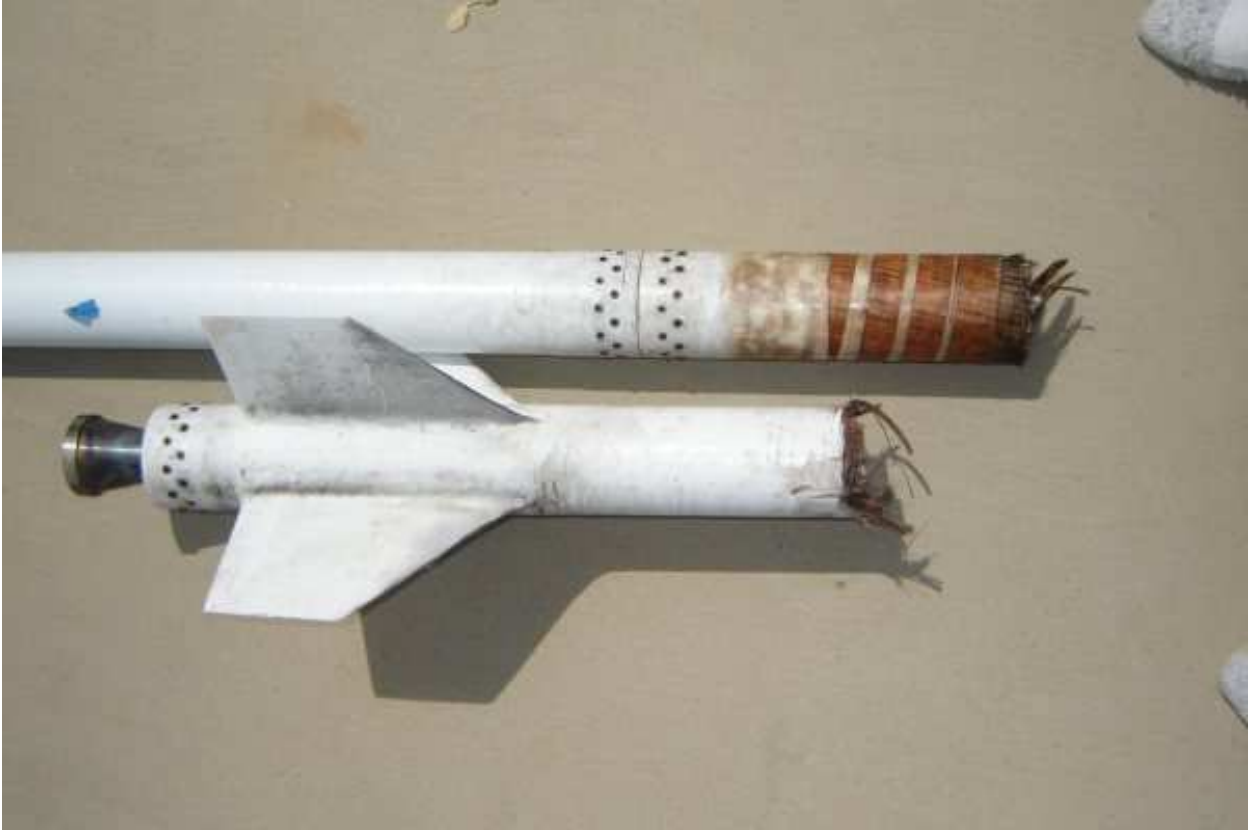
Photo 17 – Recovered sections of Booster

The Booster was found to have fractured approximately in the middle of the aft motor casing. All four fins were still attached to the aft portion, which was in good condition with the exception of the fracture (Photo 17). The inside surfaces of the casing did not display any sign of abnormal heating. The forward half of the aft motor casing remained attached to the Mid-bulkhead, and suffered severe heat damage due to the flow of the exhaust of the second phase combined with loss of the casting tubes which normally serve as a key part of the thermal protection system.

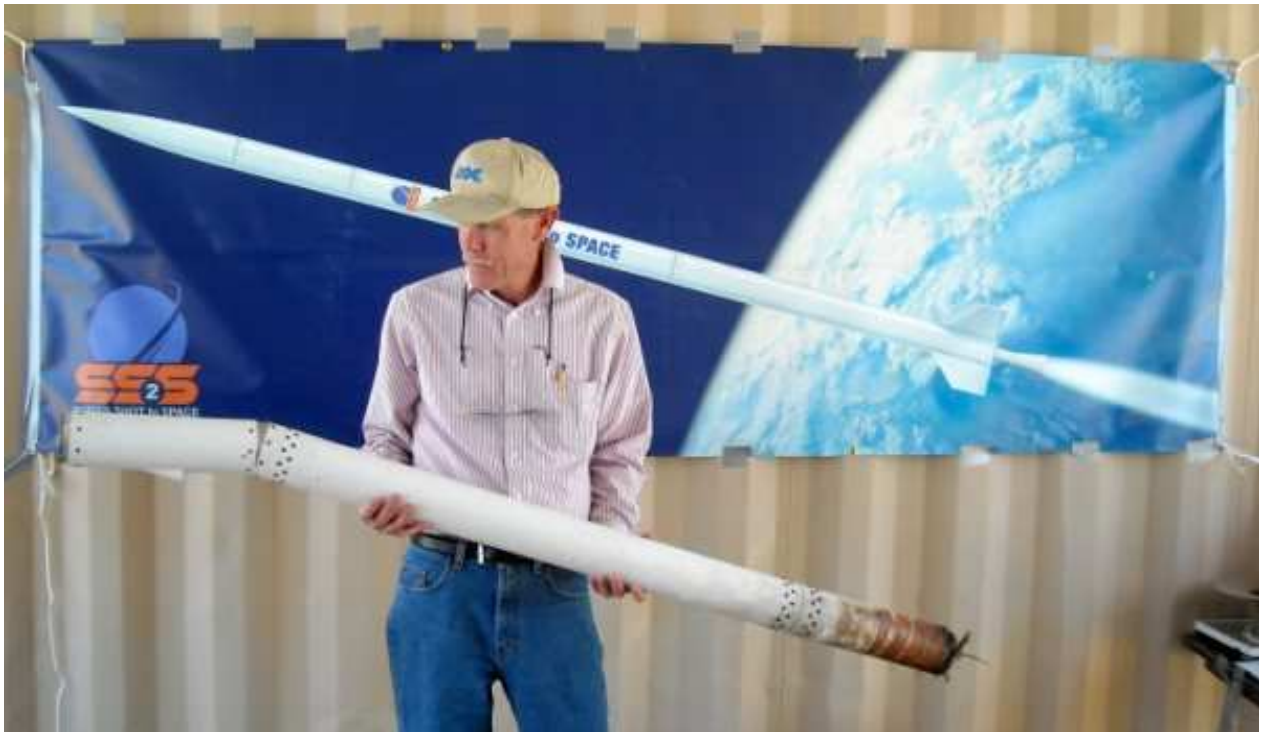
Photo 19 – Back at the FAR site, Paul Avery examines Booster

The Forward motor casing was in good overall condition with the exception of localized damage to the six holes which attach the coupler for the Aft Avionics housing (Photo 19). This damage appears to have occurred as a result of forces associated with ground impact. The interior walls of the casing experienced some heat related damage, although none greater than expected.

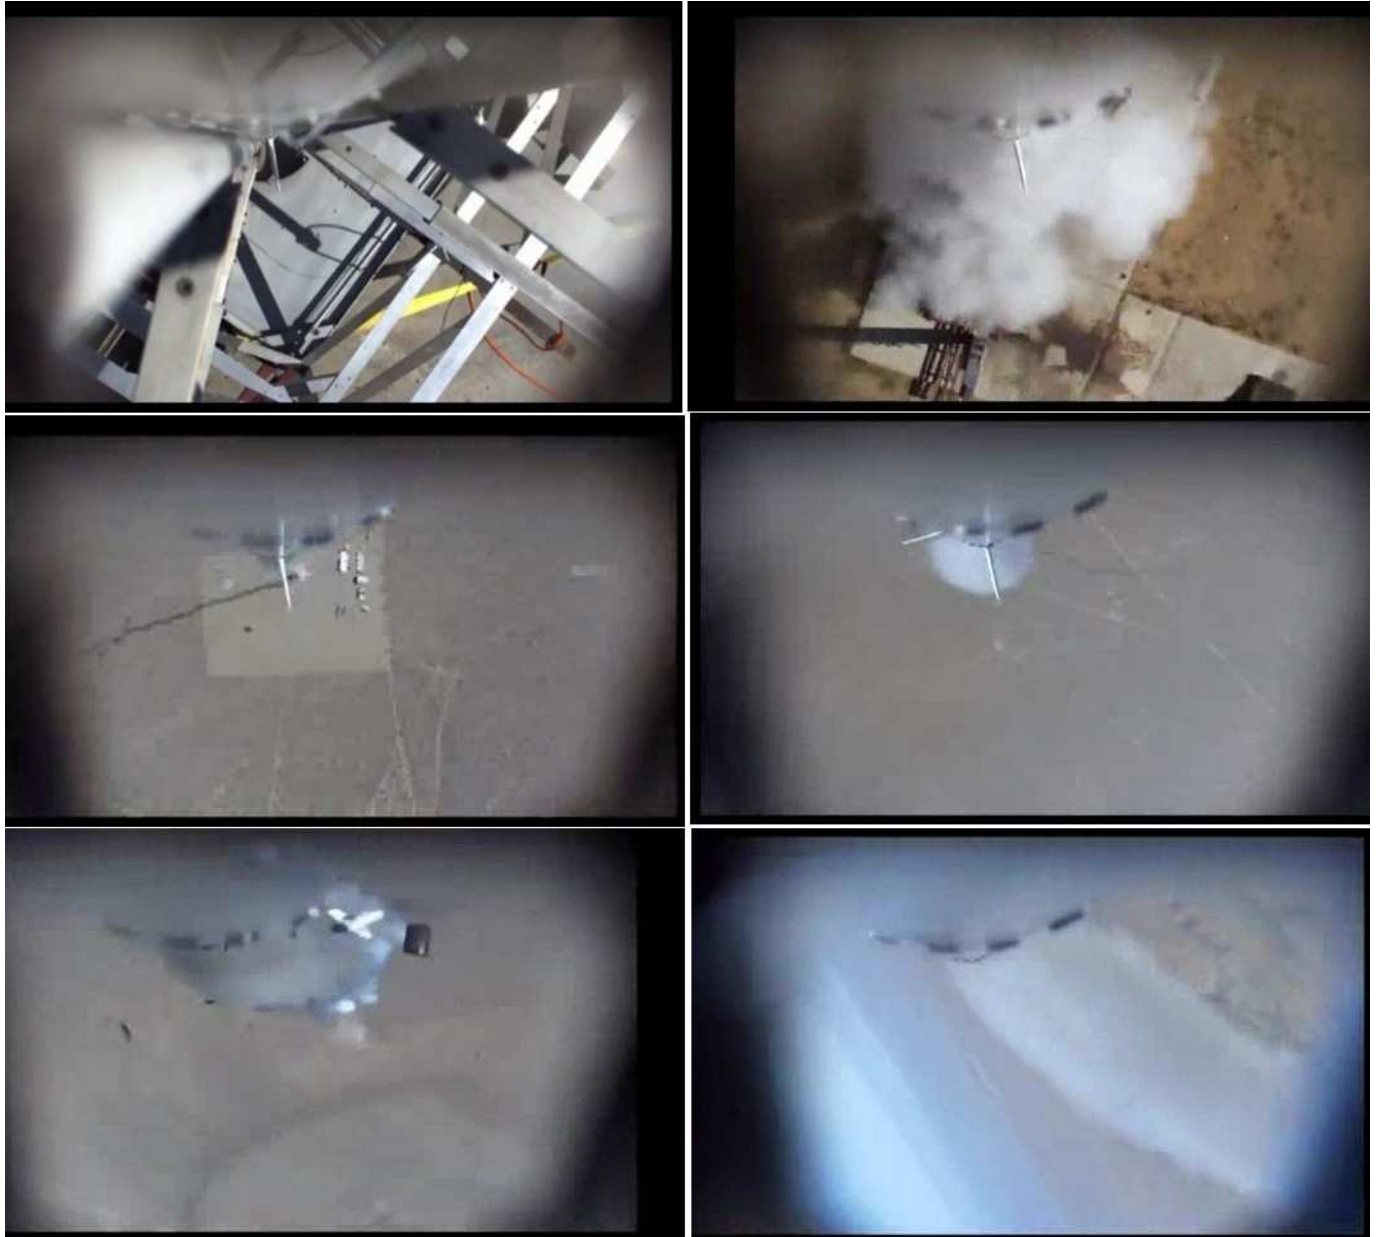
Photo 21 – Still captures from on-board video footage

Bottom left: Following motor rupture, finned portion of Booster & 2 casting tubes seen falling away

Bottom right: Second burn continues with smoke exiting through Mid-bulkhead

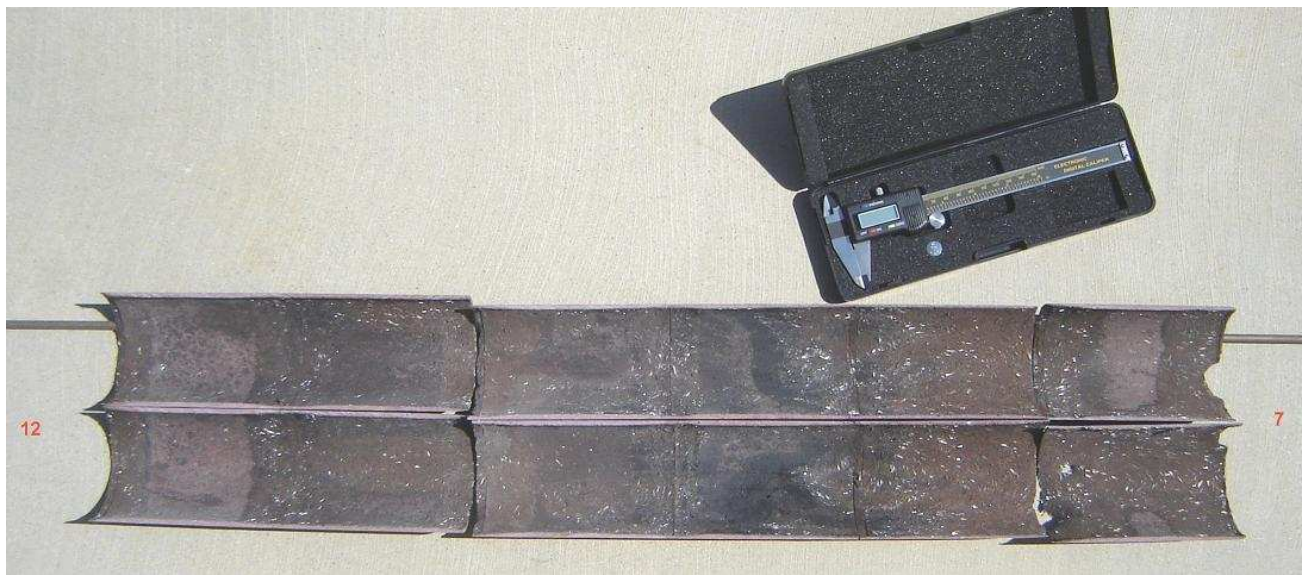
Photo 23 – Forward casting tubes after cleaning and splitting open for examination

None of the casting tubes from the aft motor chamber were recovered. After an arduous extraction from the chamber, the forward casting tubes were found to be in similar condition to that seen after the *ProtoSShot III* static firing, with a slightly greater degree of thermal degradation. Photo x illustrates the tubes after cleaning and sectioning.

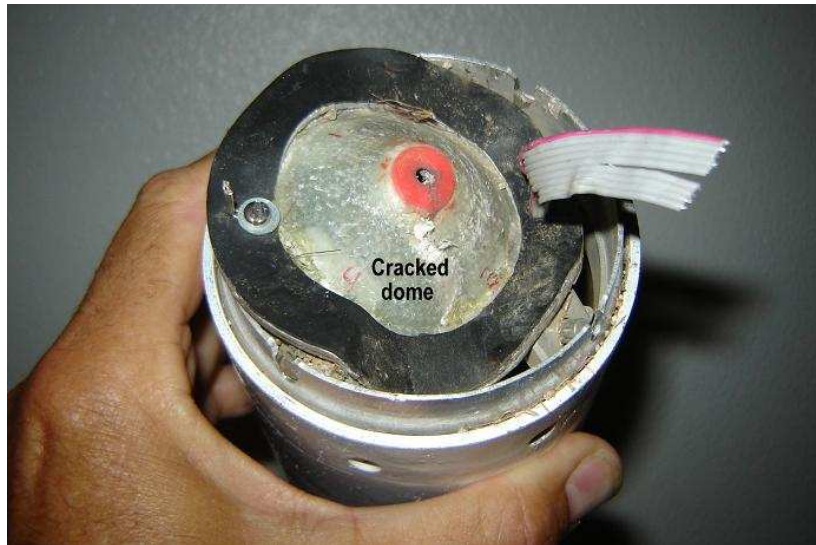
Photo 24 – PSD dome damage due to ground impact

The PSD tether anchor bolt was still attached to the booster chute tether, it had snapped off the PSD where the threads began. Three of the pin-retaining holes in the PSD coupler ring exhibited shear tear-out with the fourth intact (photo 26). The tear-out is indicative of a high bending load experienced by the vehicle, likely during the spiraling motion following the anomaly. The spiraling may well have been a result of the booster chute causing asymmetric drag during the second phase burn, which continued until the tether snapped. The PSD body was damaged from ground impact, as
