MiniSShot

ProtoSShot-M Short Stack

Review of Propellant Casting Session held August 31, 2008

Rev.2008/09/17

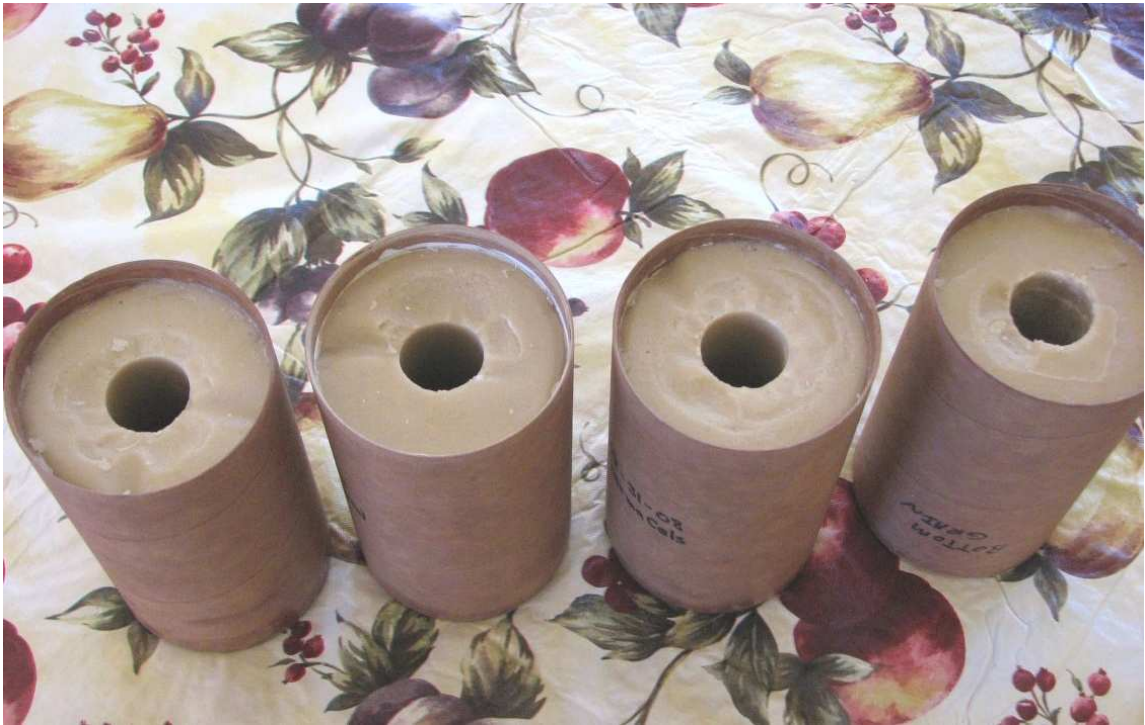
6. Vibrator motor failed after only a single casting.
7. Forgot to apply mould-release on one of the coring rods.
8. Propellant chipped on bottom surface during coring rod removal (reference Figure 3).
9. The grain top surfaces were not smooth as expected (reference Figure 4).
10. The propellant density was much lower than expected (reference Table 1).
11. Order of casting was not recorded.
12. Coring rod attachment screws tended to loosen during vibration.

Figure 3 – Bottom surfaces were chipped during coring rod removal.

8. The propellant chipped on the bottom surfaces because the coring rods were not to blueprint (had a chamfer at each end). This and other similar issues can be resolved by making sure all parts are made to blueprint.

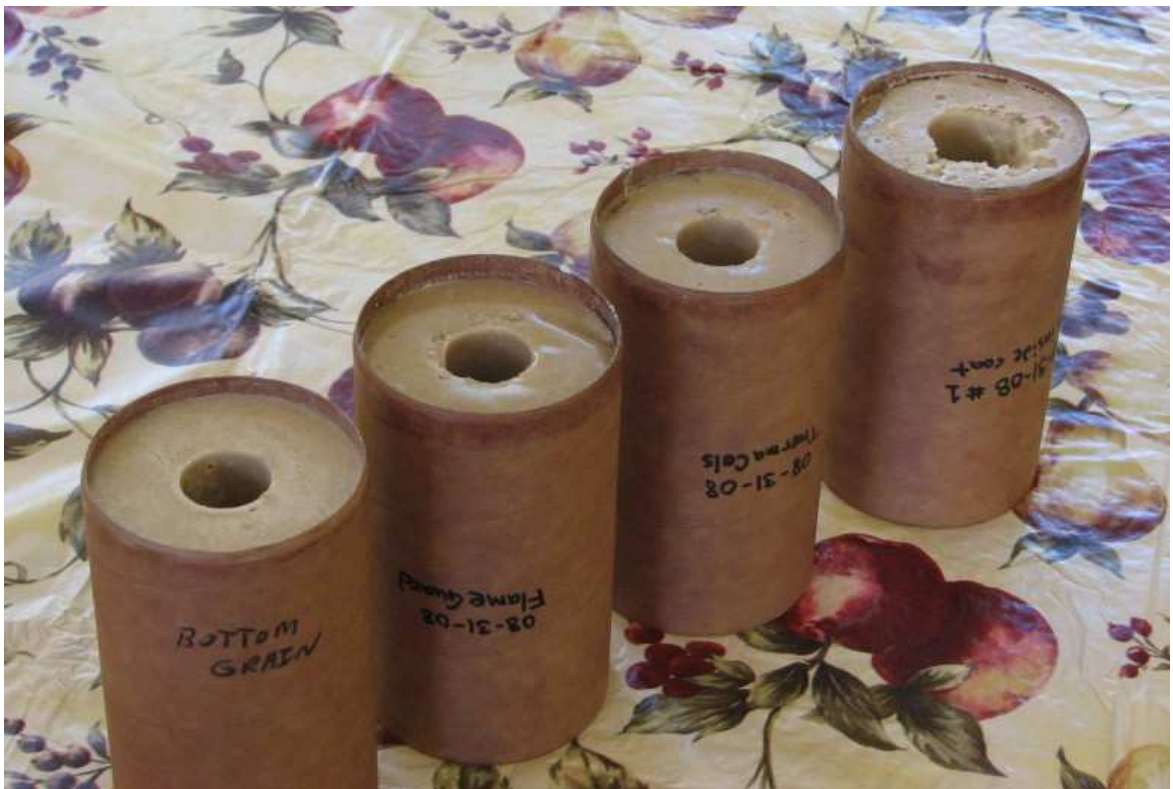
Figure 4 – Irregular propellant top surfaces.

9. The grain top surfaces were not smooth possibly because the propellant had begun to set by the time the full clamping pressure was applied. This was done 10 hours post-casting, which was the maximum specified in the casting guide. Clamping should instead be performed as soon as the propellant begins to cool and no longer has a tendency to ooze out of the mould due to the application of clamping pressure.

Another possible reason for uneven top surfaces is that the clamping pressure may have been insufficient. The springs have a load rating of 165 lbs/inch and when fully compressed, produce a force of 140 lbs. This translates to the propellant being subjected to a hydrostatic pressure of 40 lb/sq.in. Springs with a higher load rating may be beneficial.
