“1/4 Scale” Ballistic Evaluation Motor (BEM)

1st Static firing report

Rev. 2006/04/03

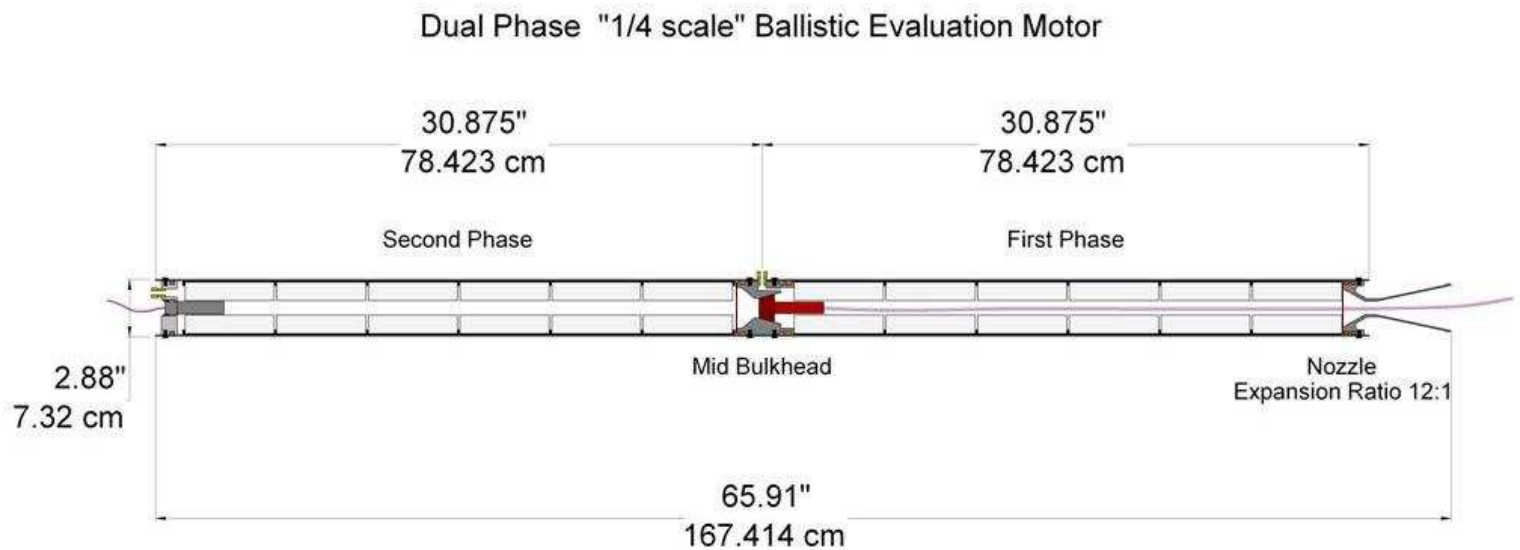
Details on the design and construction of the BEM are outlined in the Technical Specifications Paper Rev. 2005/08/28. Detailed dimensions can be found in the BEM CAD files of the motor. Overall dimensions and layout are summarized below.

The BEM is designed to burn in two distinct phases, separated by a delay of approximately 15 seconds. Both phases are designed to be as similar as possible. Both phases incorporate head end pyrogen ignition and a burst diaphragm. The burst diaphragms, which were fabricated from nylon fabric reinforced epoxy, are designed to burst at 150 psi, without fragmentation. The motor is constructed almost entirely of steel. Steel tubing in the form of EMT tubing was chosen as the casing material because it has long been used successfully by AER enthusiasts as a reliable casing material for sugar-based propellants.

The nozzle is a conical profiled, deLaval supersonic type machined from steel (12L14), featuring 30° convergent and 12° divergent half-angles. The expansion ratio is 12:1, with MEOP being 1100 psi (7.6 MPa.). The nozzle is attached with alloy steel machine screws. To provide an effective and redundant pressure seal, two silicone o-rings are used in conjunction with silicone grease.

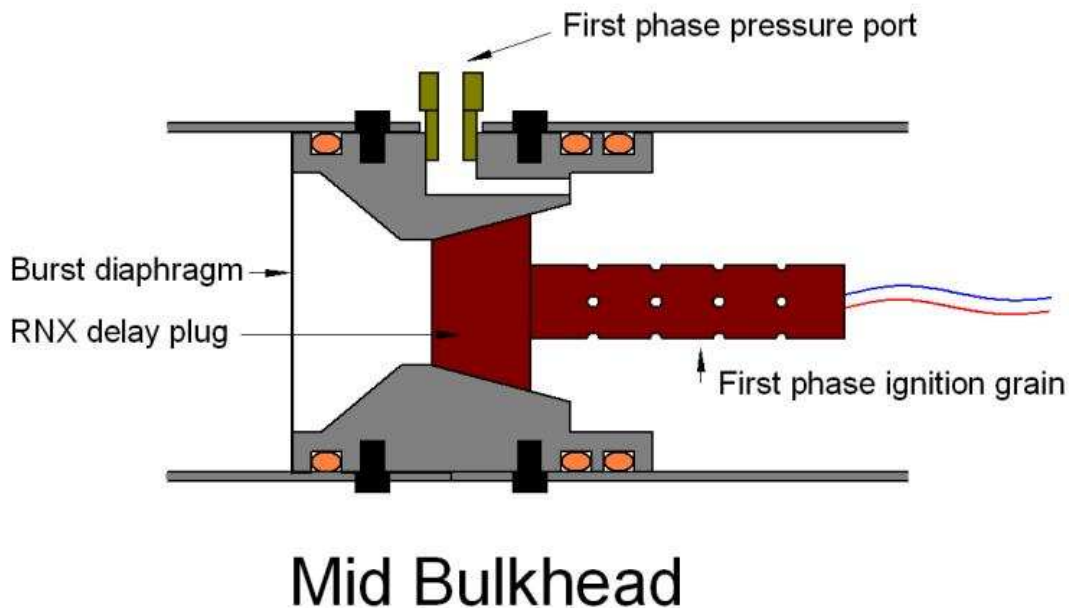
Figure 1 – Design details of mid-bulkhead assembly

The mid-bulkhead, is designed to connect the two casing sections and to fully isolate the 1st phase chamber from the 2nd phase chamber during the operation of the 1st phase. An integral “delay plug” is ignited at the same time as the 1st phase and is sized to burn completely through within 15 seconds of ignition. The delay plug material is RNX propellant, comprised of a mixture of epoxy, potassium nitrate and iron oxide. The mid-bulkhead is machined from steel and is attached to each casing section with alloy steel machine screws. Two silicone o-rings are used on the 1st phase side, and one o-ring is used on 2nd phase side. All o-rings are used in conjunction with silicone grease. The burst diaphragm for the 2nd phase serves double duty as it also provides protection against accidental ignition of the 2nd phase grain from combustion heat of the delay plug. The mid-bulkhead also contains a pressure port to allow for measurement of chamber pressure during the first phase burn. Ignition of the 1st phase is accomplished with a small KN/dextrose/iron oxide propellant grain “pyrogen” with the same overall dimensions as the one contained within the pyrogen canister of the 2nd phase. The pyrogen grain for the 1st phase is not contained within a canister and is glued directly to the RNX plug. Additionally, the 1st phase ignition grain has sixteen small holes drilled into it to increase its initial surface area and to allow for flame impingement on the motor grain core surface. The design of the mid-bulkhead assembly is shown in Figure 1.

The main objective of this first firing of the BEM, to prove the “dual-phase” concept, was largely achieved. The mid-bulkhead with integral delay plug performed as expected and successfully isolated the two combustion chambers. The delay grain was consumed following 1st phase firing, although at a somewhat slower rate than expected. The 2nd phase fired well and the presence of the mid-bulkhead did not seem to be detrimental to the performance. In fact, the 2nd phase maximum thrust was slightly higher than that of the 1st phase. The shape and magnitude of both thrust curves were similar, and basically followed the profile of the design curve. Tentative performance numbers were obtained. The 1st phase casing failure appeared to be due more to “misfortune” than anything else. Data collection worked well with the exception of that of the thermal sensors. Precise calibration of the pressure and thrust sensors proved to be more of a challenge than expected.

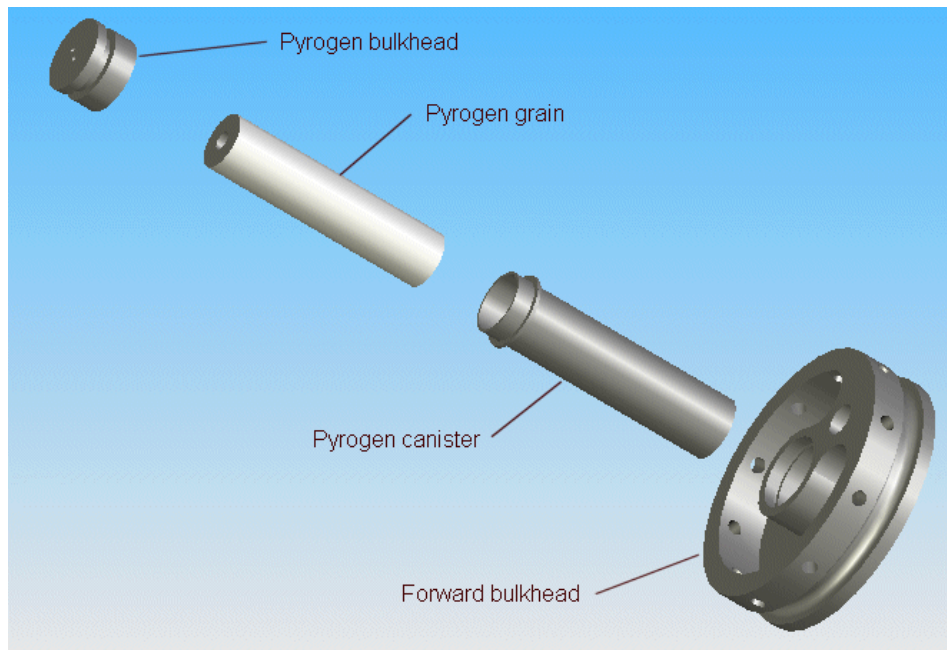
Figure 2 – Design details of forward bulkhead assembly

The upper bulkhead is machined from 6061-T6 aluminum alloy. It is attached with alloy steel machine screws. For sealing, the bulkhead is provisioned with a single o-ring used in conjunction with silicone grease. Additionally, silicone grease was applied to all surfaces exposed to heating. The bulkhead contains a pressure port for measurement of 2nd phase chamber pressure. This bulkhead also has a provision to retain the pyrogen igniter canister.

The Pyrogen Igniter as installed in the forward bulkhead is illustrated in Figure 2. The canister is machined from stainless steel bar stock, and retained by a retaining ring (snap-ring). The igniter leads are fed through the two holes on the top of the canister, and are sealed and secured by filling the holes with epoxy.

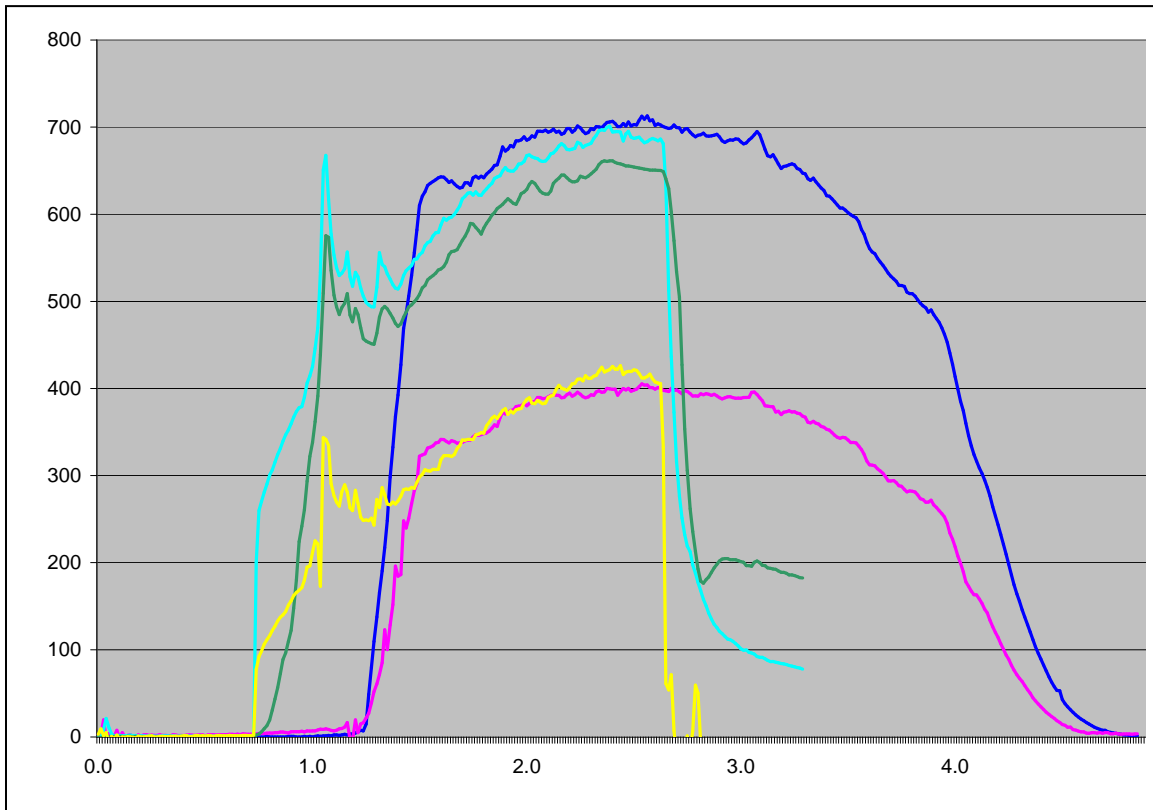
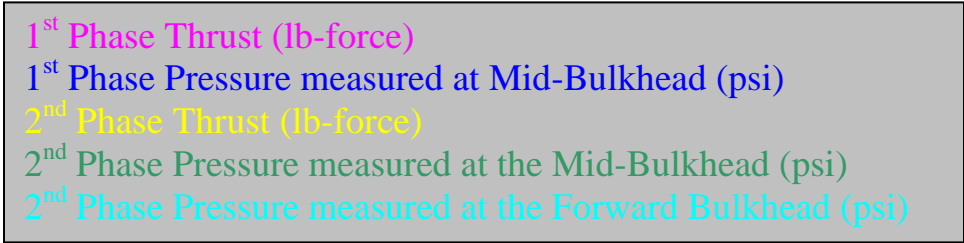
Figure 3 – Measured thrust & pressure data

Examination of the motor following the firing showed that the 1st phase casing had burst open at the welded seam just aft of the mid-bulkhead. Despite tearing loose from the stand, good pressure and thrust data was obtained from both the 1st phase and 2nd phase firings, as shown in Figure 3. Data from the thermal sensors, which had been attached to the motor casings, was not salvaged.

With regard to what led to the casing failure, the initial thought was that a nozzle blockage had occurred, leading to a pressure spike which caused the failure. However, examination of the collected pressure and thrust data showed that there was no pressure spike at the moment of failure. Rather, the chamber pressure had at this point started to tail off to some extent, as can be seen in the 2nd phase pressure curves in Figure 3 (cyan & green curves). Subsequent examination of the damaged casing showed that the butt-welded seam was of inferior quality to that usually found on EMT tubing. In hindsight, this deficiency had been hinted upon during the proof pressure hydro-test when leakage occurred. Examination of new sections of *Republic* brand tubing revealed that this was indeed the case. The weld was not the full thickness of the tubing wall. This is unlike the seam of *Allied* brand tubing (the usual brand of EMT used for motor casings), which has consistently proven to be of excellent quality. Thermal loading with consequential reduction in seam strength were contributing factors that led to the failure.

As is seen in the pressure and thrust curves of Figure 3, the motor came up to operating state quickly, for both phases of operation. The pyrogens were clearly effective in this regard. The spikes at the beginning of the 2nd phase burn were the result of inhibitor debris being ejected through the nozzle, as was witnessed by the observers. The shapes of the 1st phase curves were fairly close to the shape of the design curve. The performance curves did not exhibit the unwelcome “triangular” shape that is often seen in KNSB powered motors.

Using the curves shown in Figure 3, the motor performance was calculated for 1st phase operation and is given in Table 1. Figure 4 illustrates the Thrust Coefficient (C_f), computed from chamber pressure, thrust, and nozzle throat area.

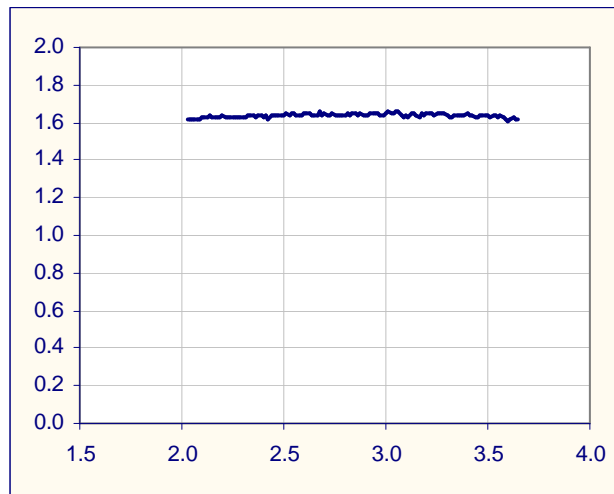
Figure 4 -- 1st phase Thrust Coefficient over steady-state duration of motor operation based on measured data

Upon inspection, these performance values indicate a markedly lower performance than expected, with the exception of Thrust Coefficient, which is plotted in Figure 4. The Thrust Coefficient, which was nicely constant over the steady-state operating duration, was significantly higher than expected. Investigation of why this was the case led to the conclusion that calibration of both the load cell and the pressure transducer was imprecise. Inconsistencies turned up during attempts to recalibrate the sensors following the discovery of less-than-expected performance.

Another indicator of miscalibrated pressure data is the unusually high value for the Thrust Coefficient (Figure 4). As shown in Table 1, the maximum value for the computed Thrust Coefficient based on measured data was $C_f=1.66$. Experience based on numerous static firings of sugar-based motors suggests a more realistic value of approximately $C_f=1.5$. Using the adjusted pressure values based on a 95% c-star ratio, the revised maximum Thrust Coefficient becomes $C_f=1.47$, as realistic value.

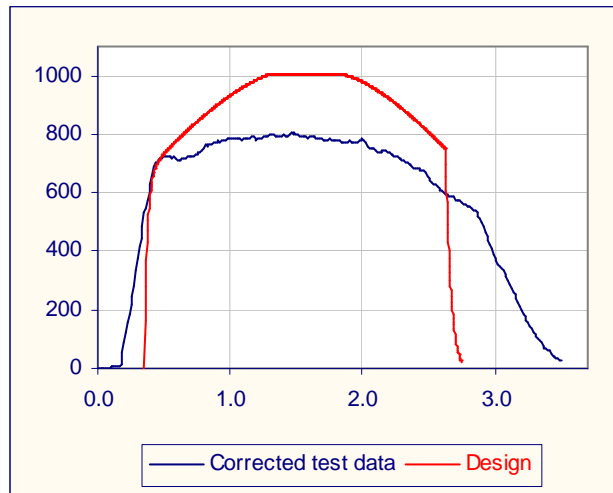
Figure 5 – Chamber pressure comparison

measured data, as shown in Table 1, was 84% of ideal, clearly unrealistic. The adjusted pressure plot based on a c-star ratio of 95% is shown in Figure 5, in comparison with the design curve.

The chamber pressure is nevertheless significantly lower than design, and the burn time is longer. This is not entirely unexpected, as the design curve is based on propellant made from finely milled KN and made from extremely well blended KN and sorbitol, neither of which represented the actual propellant used in this first test firing. Consequently, the propellant burn rate was slower, leading to lower chamber pressure and a longer burn time. The presence of residual moisture in the propellant is another possibility that, if present, would be a contributing factor to the slower burn rate.

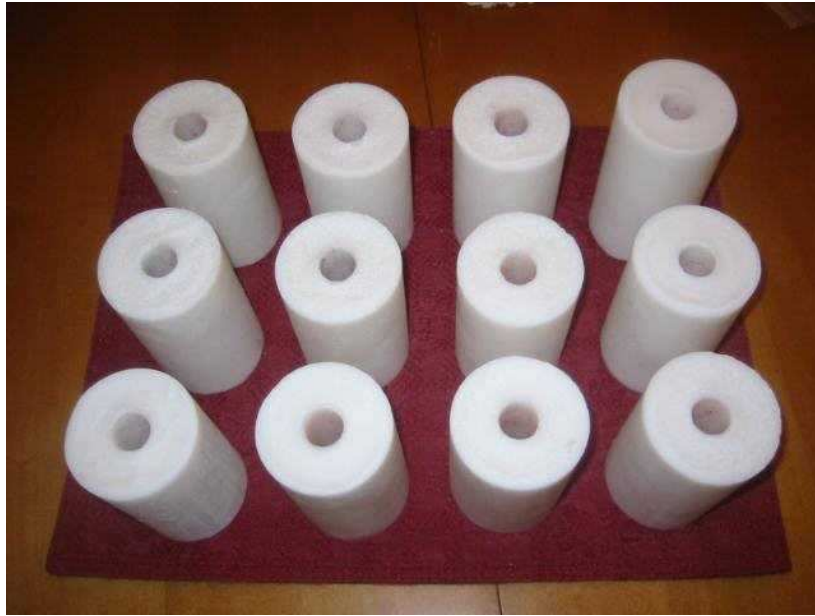
Photo 1 – Propellant grain segments prior to inhibiting

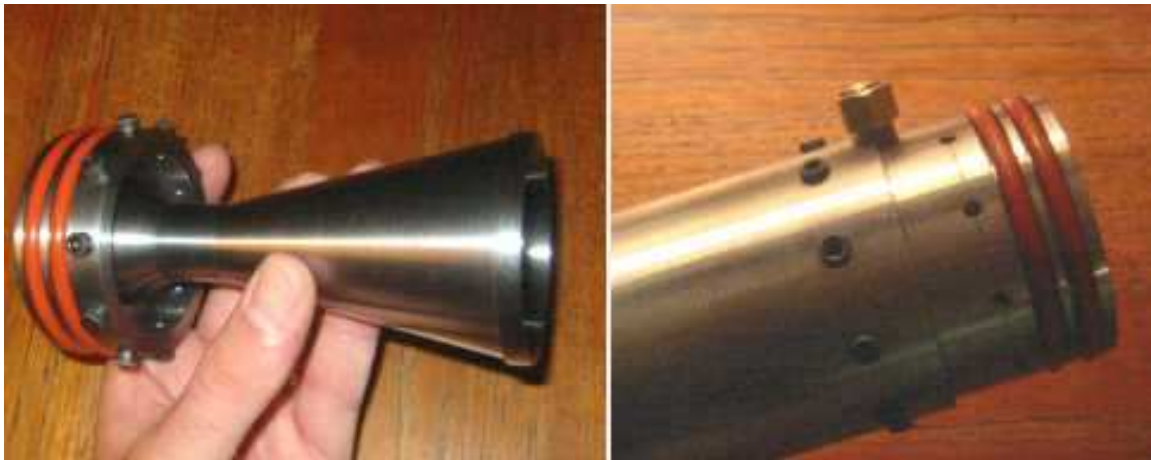
Photo 2 – Nozzle (left) and installed mid-bulkhead (right)

With regard to the post-firing condition of the motor, damage was relatively light. Other than the burst casing, the only other significant damage was a bent nozzle due to impact with the ground.. The throat was measured and no measurable erosion was found, despite the extreme heating.

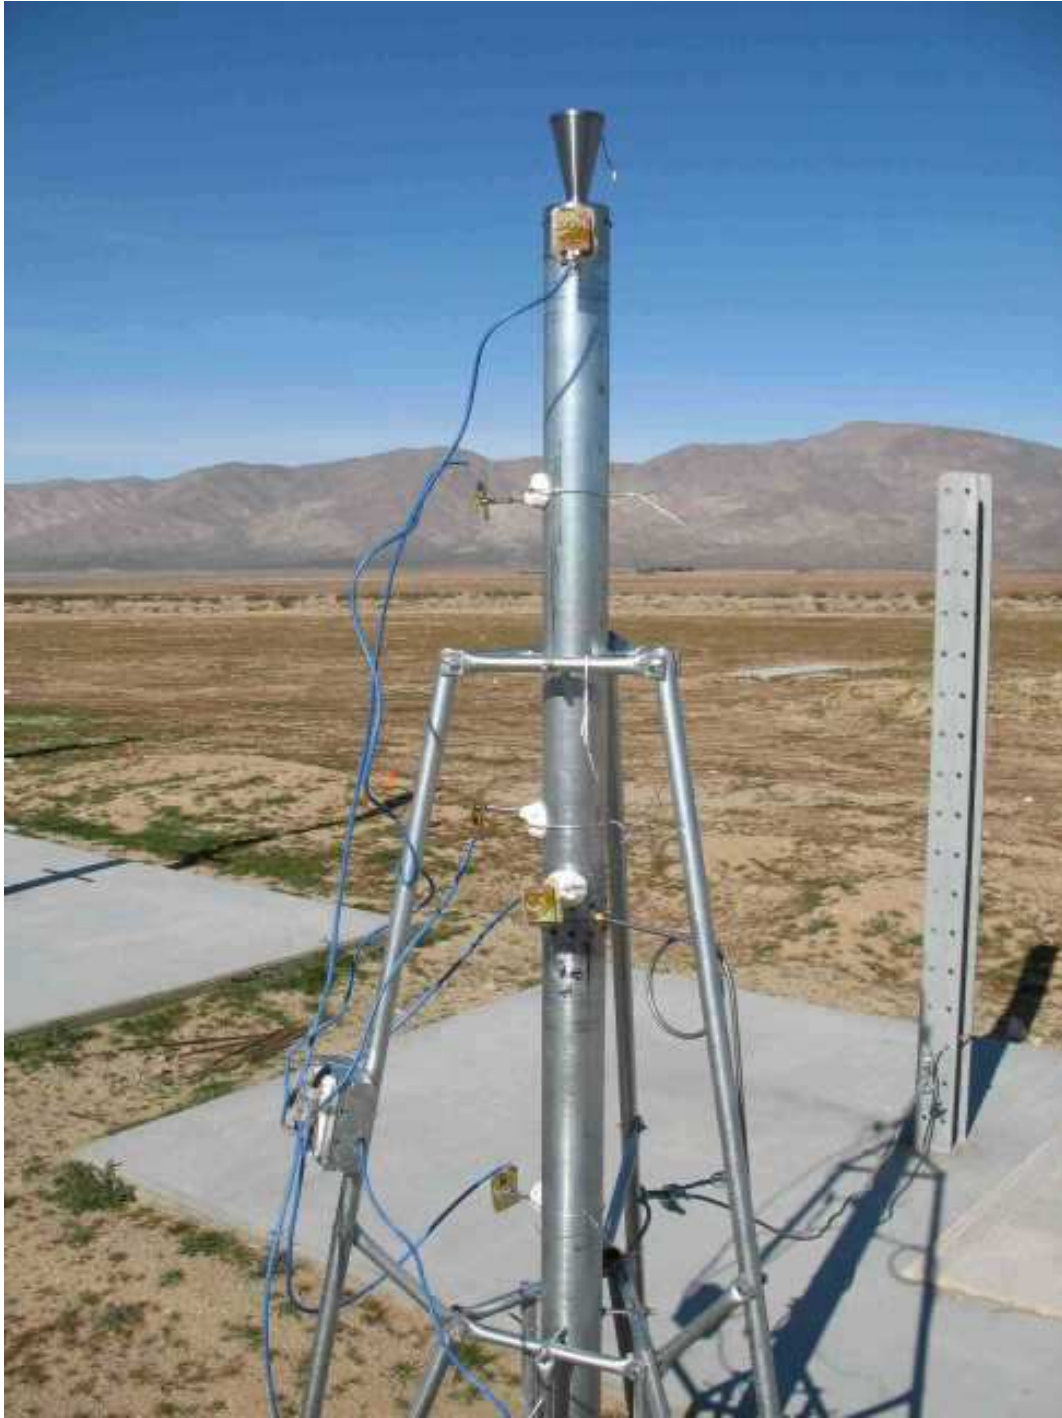
Photo 3 – Instrumented $\frac{1}{4}$ Scale BEM in static test stand

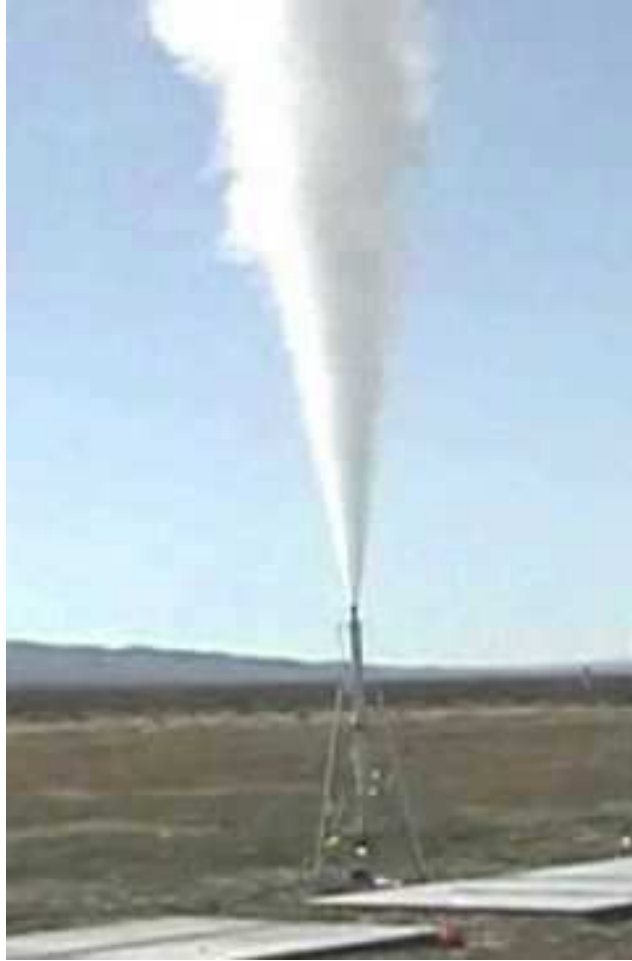
Photo 4 – 1st phase motor undergoing full thrust

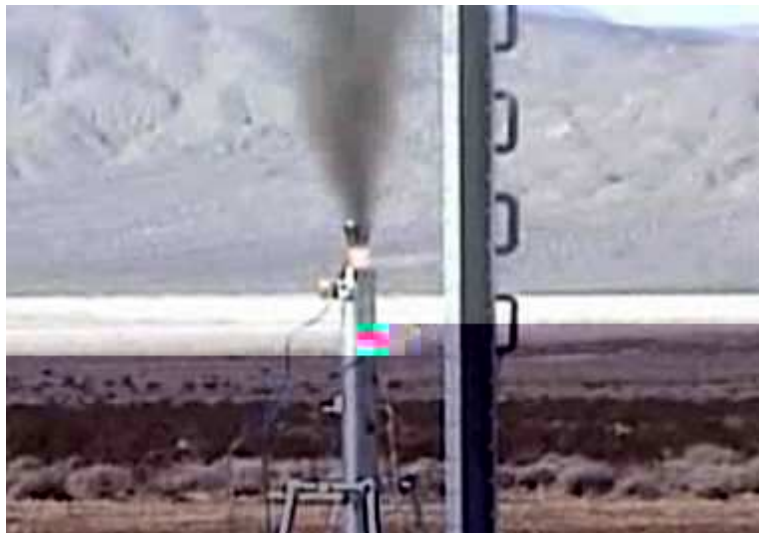
Photo 5 – Nozzle glowing after 1st phase burnout. Smoke from burning delay plug

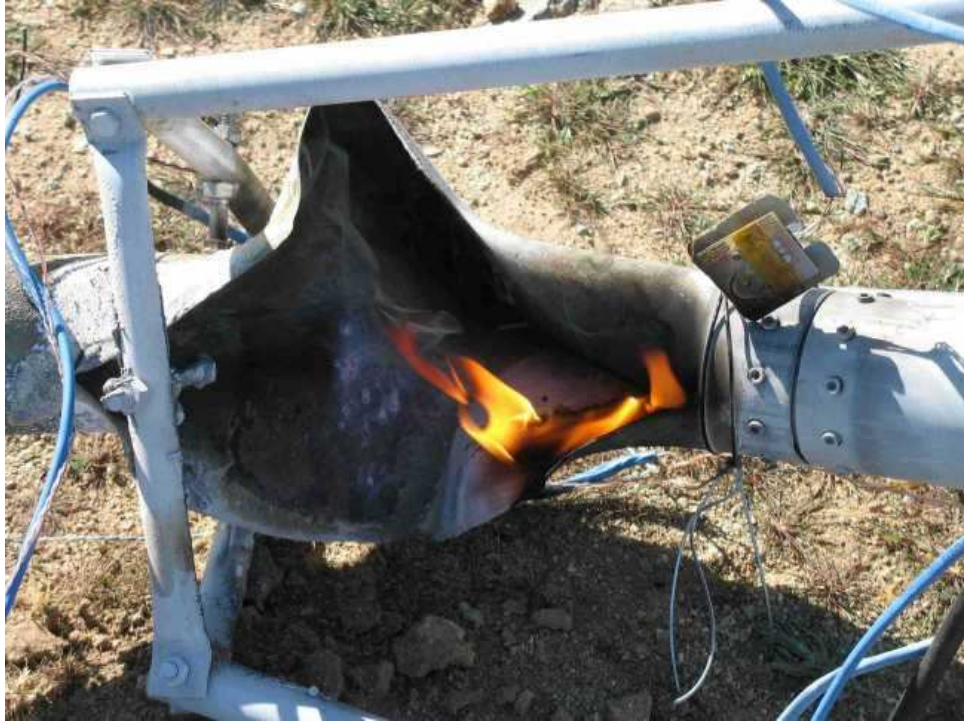
The casing material for this first test was *Republic* brand Electric Metallic Tubing (EMT). The casing was hydrostatically tested and on the initial test was found to leak at the mid-bulkhead. A quick look at the casing showed that the welded seam in the area of the leak contained a “valley” that allowed pressure to get past the o-rings. This area was filled with JB-weld and sanded smooth and later proved to provide a good seal. The EMT’s zinc coating was left intact.

Photo 6 – Ruptured 1st phase casing aft of mid-bulkhead

- *Allied* EMT tubing will be used for both casings
- A higher hydro-test pressure will be used
- A means of insulating or cooling the 1st phase casing at the critical location will be implemented
- Pressure sensors and load cells will be redundant and more carefully calibrated
- Thermal sensors will be improved in terms of mounting, calibration and data acquisition
- Propellant will be prepared more similarly to that of the design condition.
- The replacement nozzle will have a heavier throat section
