MiniSShot

Launch Report

Rev. 2010/08/15

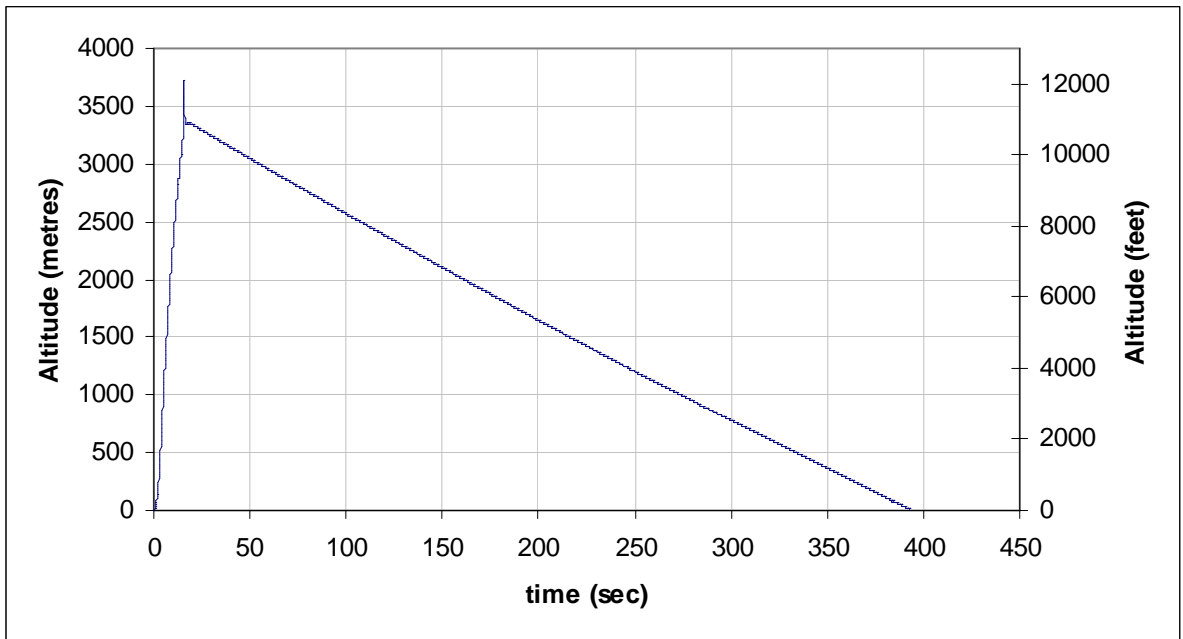
Figure 2 – Plot of CC altitude (AGL) versus time over entire flight

From Figure 2, the Payload Capsule average descent rate was determined to be 29.4 fps (8.97 m/s) and touchdown velocity was 27.4 fps (8.36 m/s). This compares favourably with the design touchdown velocity of 32.2 fps (9.81 m/s).

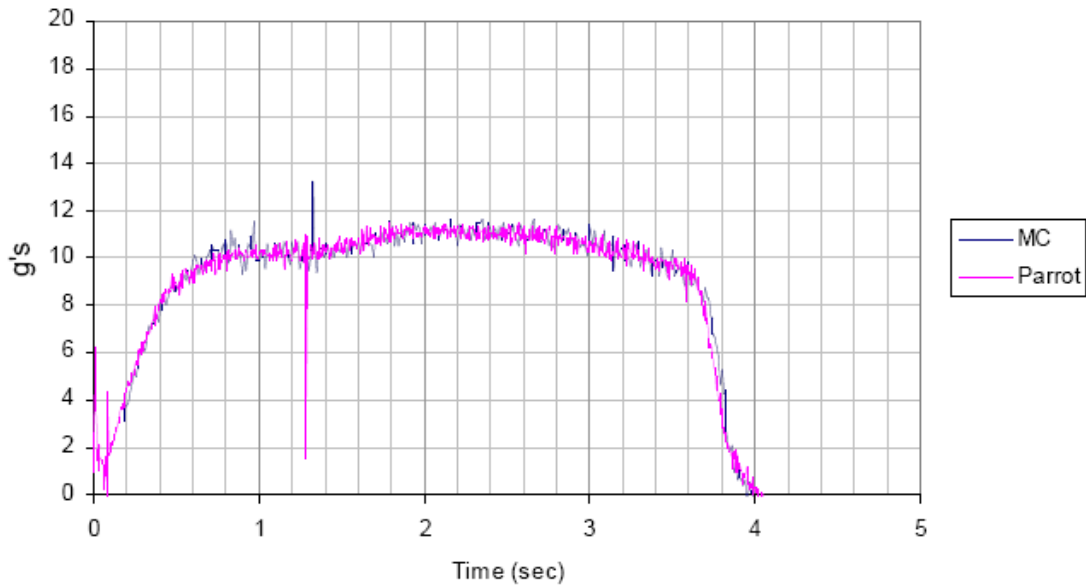
Figure 5 – Plots of acceleration during 1st burn

An examination of the vehicle axial acceleration during the 1st phase burn, as shown in Figure 5, reveals a curious spike about a third way into the burn. The Parrot records this as a decrease in acceleration, yet the MC records this as a positive spike. The two spikes do not coincide exactly, separated by perhaps 50 milliseconds. As such, these may be two separate but related events.

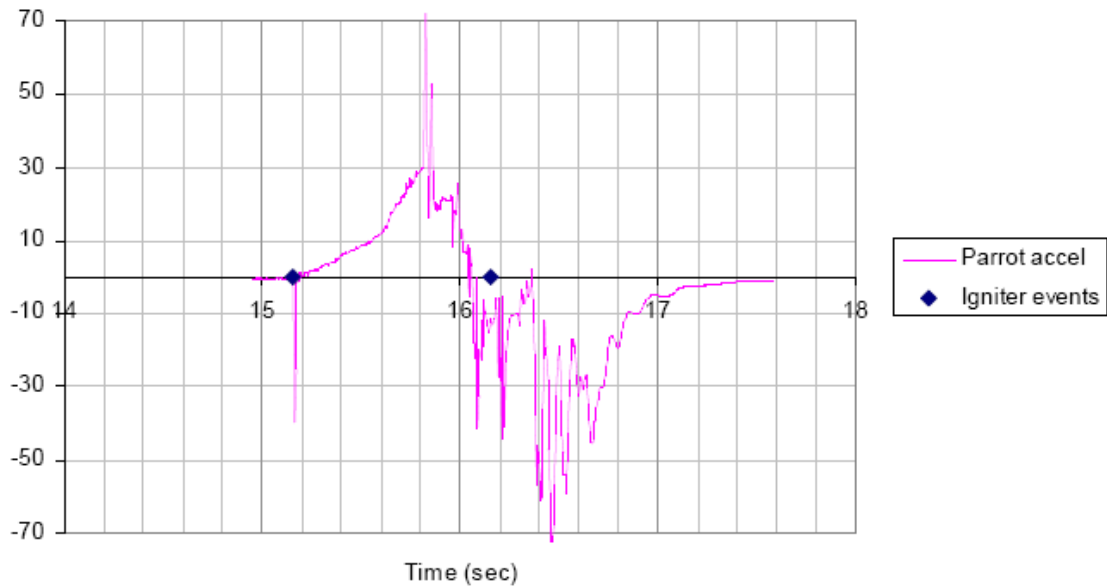
Figure 7 is a plot of vehicle acceleration during the 2nd phase burn and subsequent motor casing rupture. Two igniter events are shown. The first igniter event is “power on” to the booster igniter and the second event is loss of continuity of both the booster igniter and the CC pyro igniter. This

implies the event coincides with physical breaking of the igniter wires and thus separation of the Payload Capsule from the Booster.

Figure 7 – Acceleration and motor igniter events for 2nd phase burn

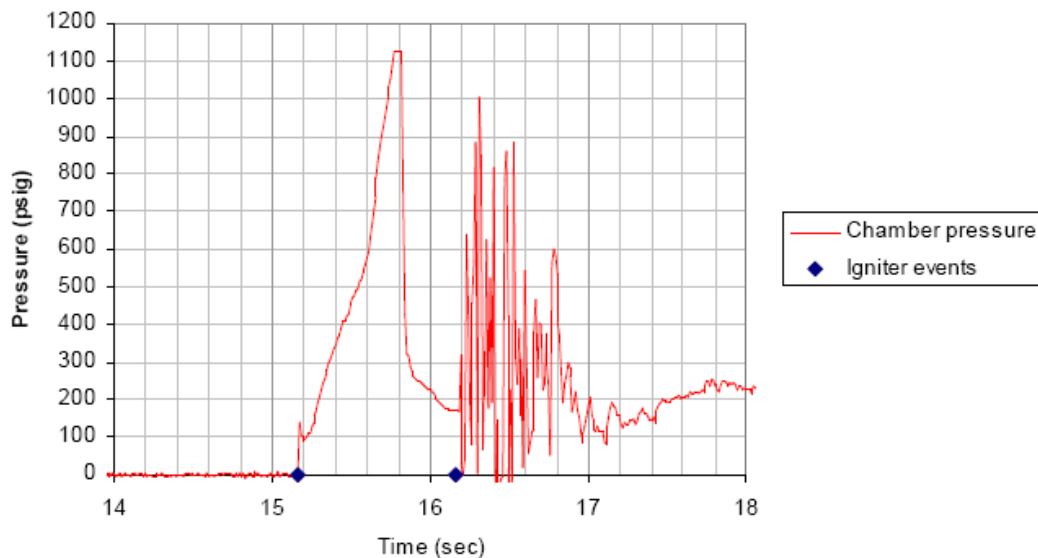
Figure 8 is a plot of chamber pressure during the 2nd burn (note there was no provision for chamber pressure readings to be sensed during the 1st burn). In Figure 7 it can be seen that the pressure readings after separation are invalid as a result of severed electrical leads, which coincided (within a fraction of a second) with the second igniter event shown (loss of drogue pyro continuity). The pressure reading is clipped at 1130 psig, at which point the 1000 psi capacity transducer saturated.

Figure 8 – Plot of chamber pressure sensor data

The primary anomalous event was the rupture of the motor case during 2nd burn. The rupture was a result of structural failure of the aft motor casing/airframe at approximately mid-span due to pressure overload. Extrapolation of the pressure curve shown in Figure 8, which was clipped due to pressure sensor capacity being 1000 psig, suggests a rupture pressure of 1400 psig or greater. As a qualification for flight, both motor casings had been hydrostatically pressure tested to 1050 psig (72 bar). The ultimate design strength of the motor is 1800 psig (124 bar). The wound-fiberglass tubing (*Ameron Dualoy 3000/L*) from which the motor cases were fabricated, is structurally optimized to have equal strength in hoop and axial directions. The actual failure mode appeared to be axial. There is no evidence of significant flight loading (bending moment) superimposed upon the pressure loading leading to failure at lower than design rupture pressure. This is apparent from Figures 9 and 11 which show the pitching accelerations during the flight. The accelerations just prior to motor rupture are of a significantly lower magnitude than those during the initial portion of the flight (first 8 seconds or so), and as such, there is no indication of pitching which could have severely loaded the airframe in bending at that instant.

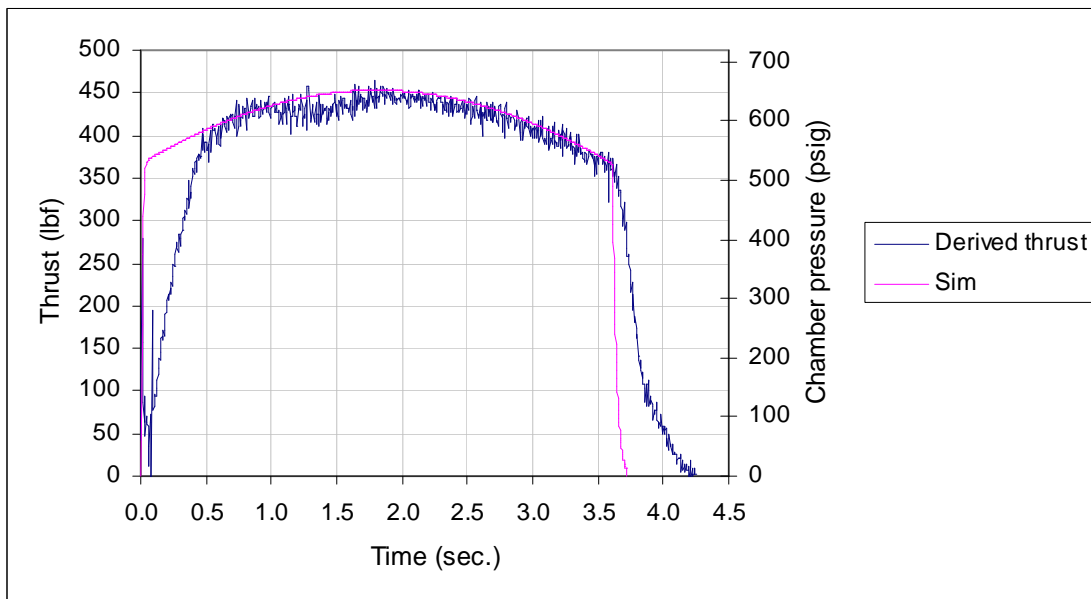
In Figure 16, the 1st phase thrust curve is derived from Parrot acceleration data and AeroLab drag data as used in the SOAR trajectory analysis. The simulation curve is obtained from SRM.XLS with the burn rate values adjusted to account for the specifics of the propellant as used for this flight. In particular, the “burn rate coefficient” was reduced due to the oxidizer being non-ground and non-desiccated. The simulated pressure curve is included to indicate the expected normal operating pressure of the motor design.

Figure 16 – Plot of derived motor thrust curve and simulation curve

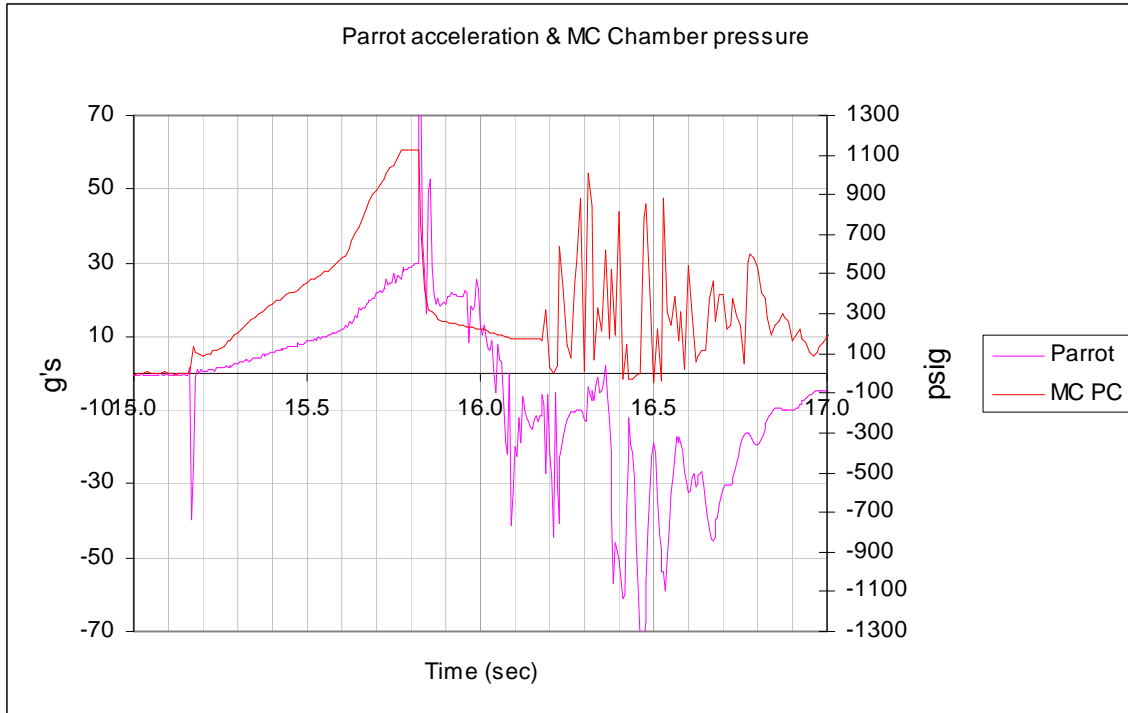
Figure 20 shows a plot of vehicle acceleration versus chamber pressure during and immediately after the motor rupture. Notice that the chamber pressure readings are invalid after the 16.1 second mark,

when the sensor leads were severed due to separation of the Payload Capsule from the Booster. During the burn, as chamber pressure rises, vehicle acceleration rises correspondingly. This response is illustrated more clearly in Figure 21, where the graph y-scales are selected appropriately to compare slopes of the two curves. The slope of the acceleration curve leading up to, and following, the sudden change in pressure rise, is seen to match the slope of the pressure curve, indicating that thrust is maintained as expected for a nominal (non-restricted) throat size.

Figure 20 – Vehicle acceleration versus chamber pressure

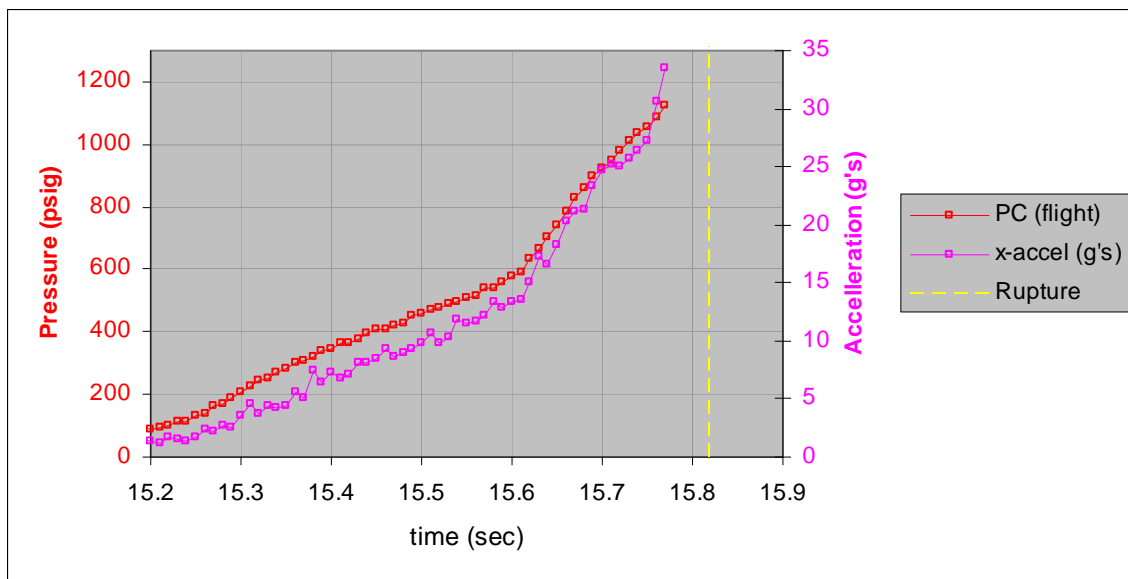
Figure 21 – Vehicle acceleration as compared to chamber pressure during 2nd burn.

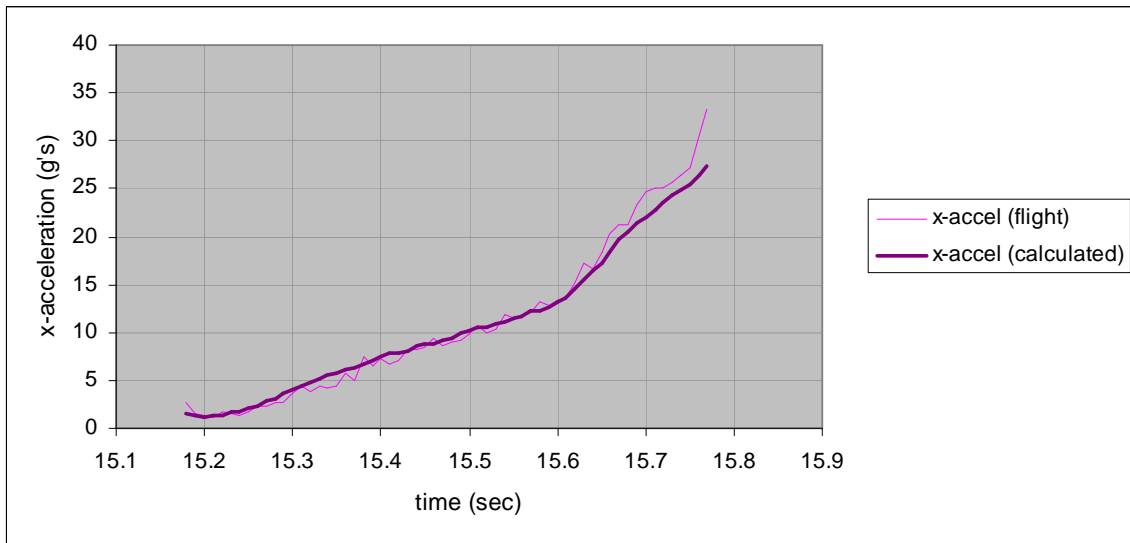
As further evidence of the throat being non-restricted, Figure 22 shows that the vehicle acceleration, based on calculated performance, assuming a nominal throat size, matches quite well the measured

Figure 22 – Actual versus calculated acceleration based on nominal throat size.

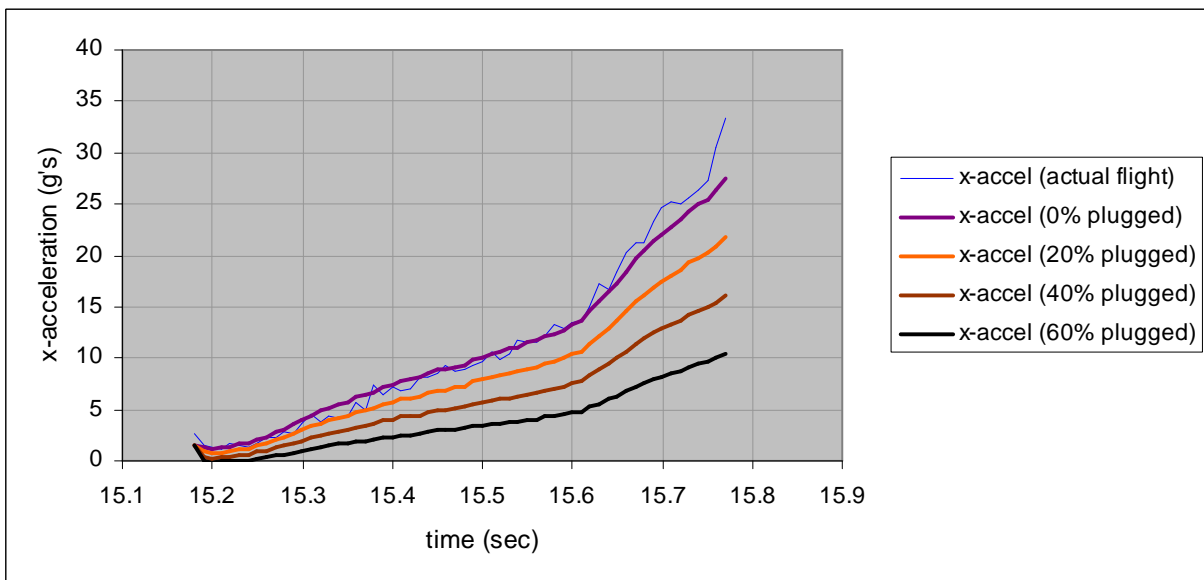
And where mass was adjusted to vary due to propellant consumption. Figure 23 illustrates the effect upon vehicle acceleration for varying degrees of assumed nozzle blockage, assuming blockage is present from the moment the 2nd burn begins.

Figure 23 – Actual versus calculated acceleration based on various degrees of throat blockage

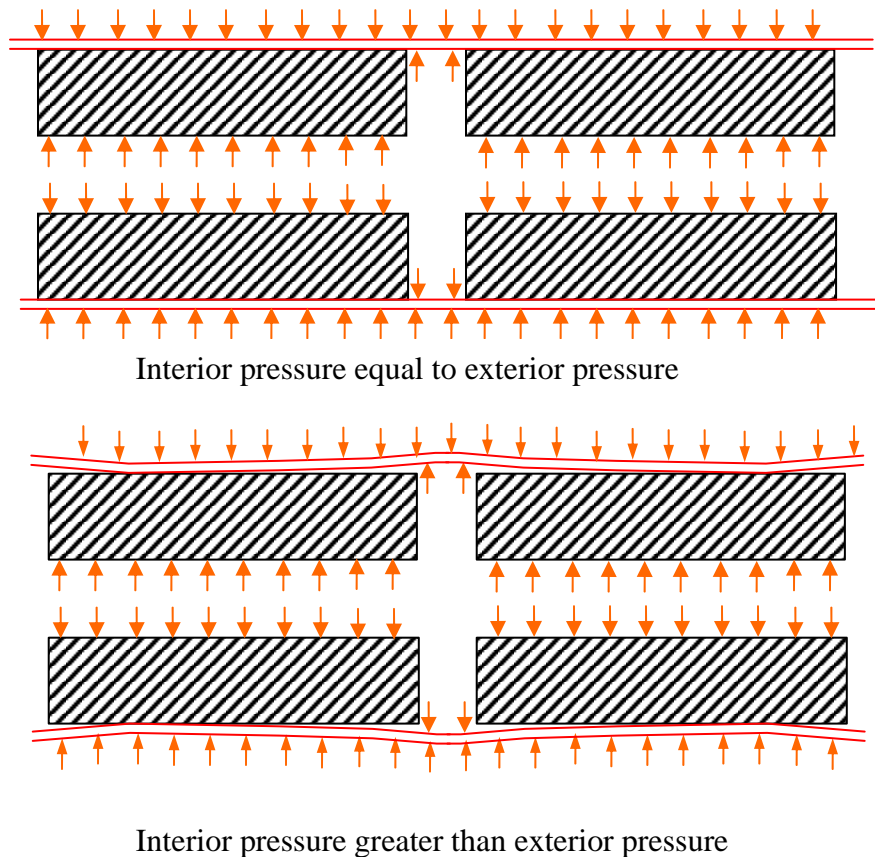
The likelihood that 3 of the 6 grain segments fully-disbonded would seem unlikely, unless there was a common cause. There is a hypothetical scenario whereby this could occur. If pressure equalization around the grain assembly did not happen rapidly enough, the resulting pressure differential between the interior and exterior of the grain assembly could conceivably be high enough to bulge the casting tubes outward, as illustrated in Figure 26 (shown exaggerated). Such a scenario could lead to multiple disbonding, if the bond between propellant and casting tube is weak. If the bond is strong, such a condition could instead lead to compound cracking of the propellant.

Figure 26 – Illustration of possible grain disbonding due to non-equalized pressure

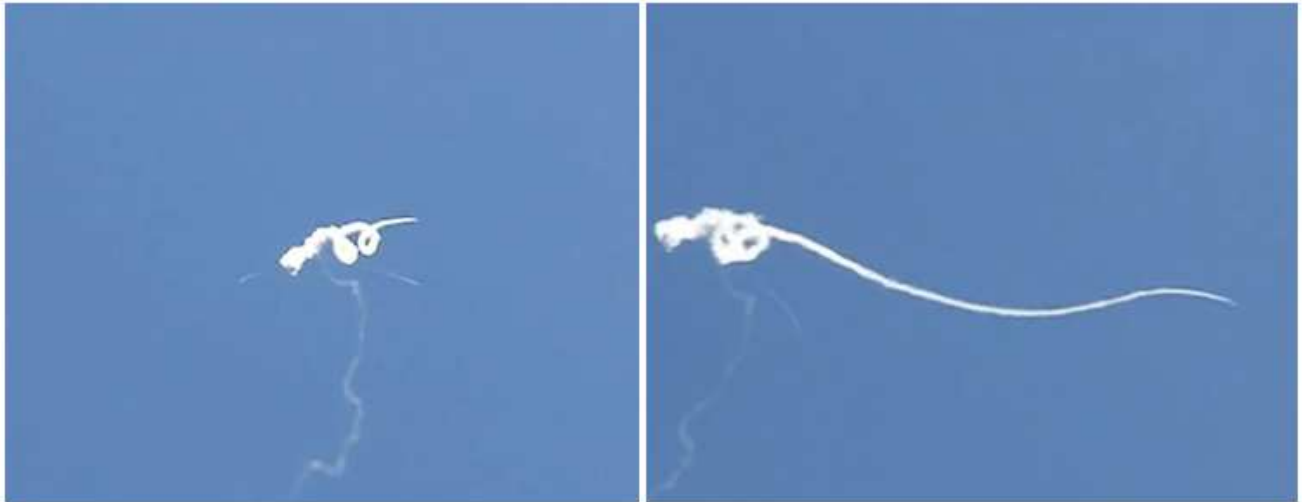
Photo 13 – Shortly after anomaly, vehicle loops twice, then trajectory straightens out

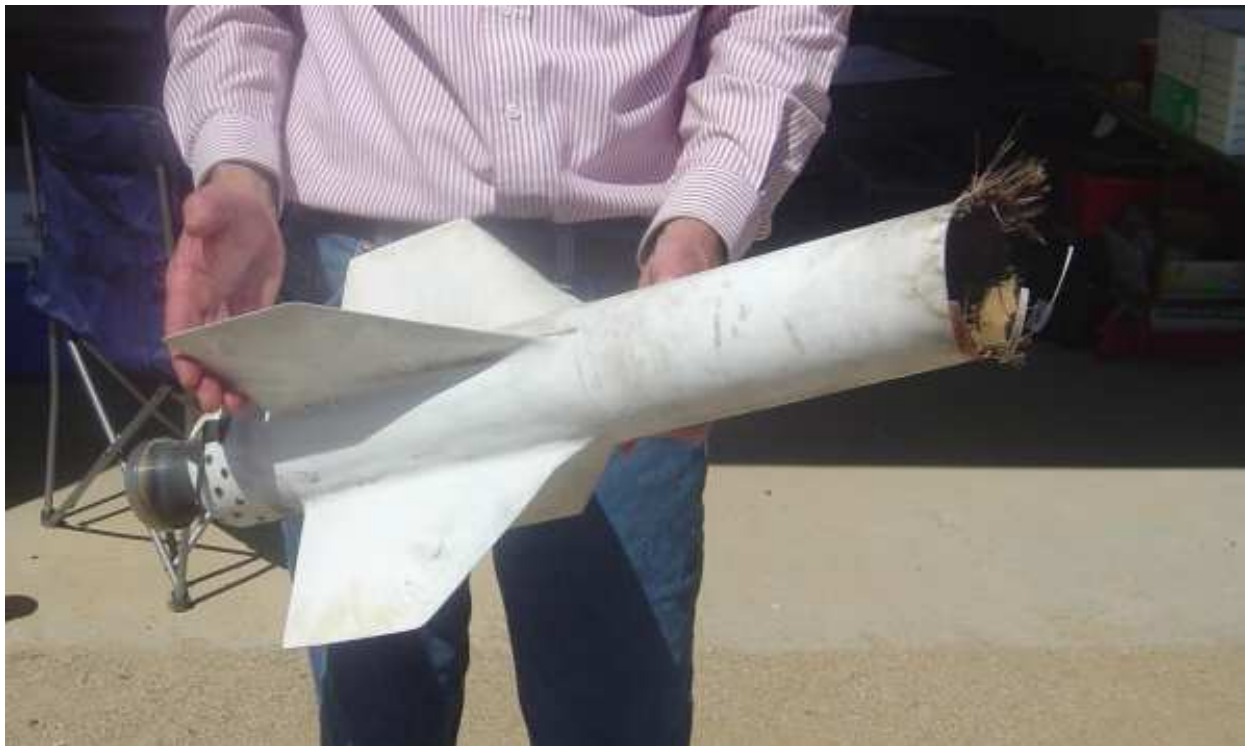
Photo 18 – Aft (finned) section of Booster

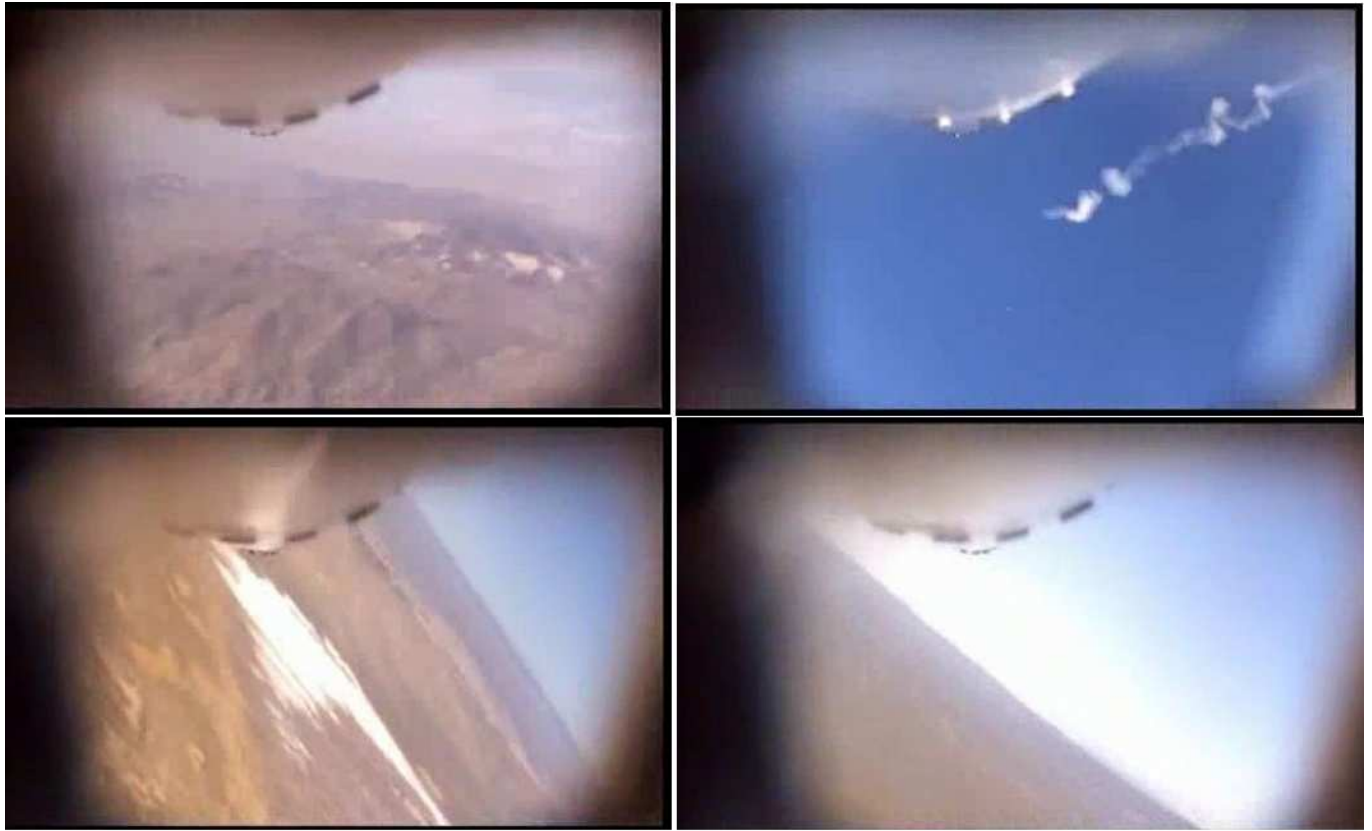
Photo 22 – Still captures from on-board video footage (continued)

Top left: View of ground terrain during Booster descent, shortly after apogee

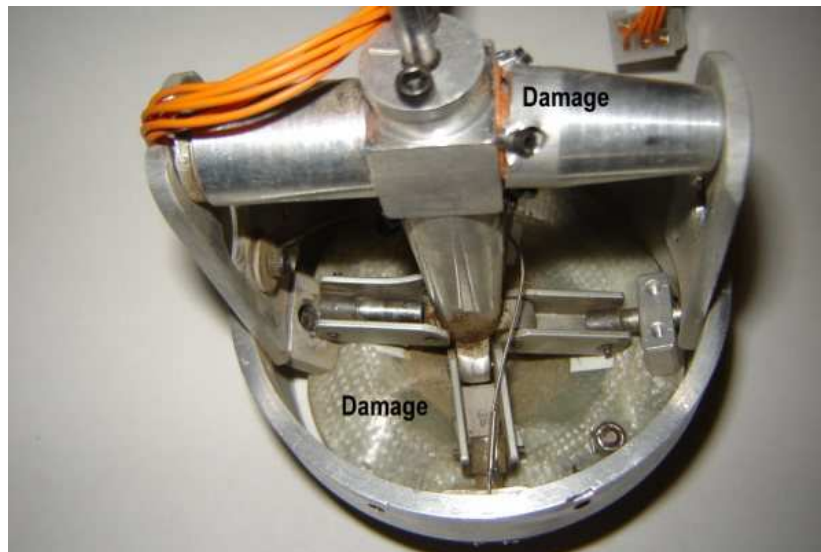
Photo 25 – PSD damage
