MiniSShot

ProtoSShot-M Short Stack

Review of Propellant Casting Session held August 31, 2008

Rev.2008/09/17

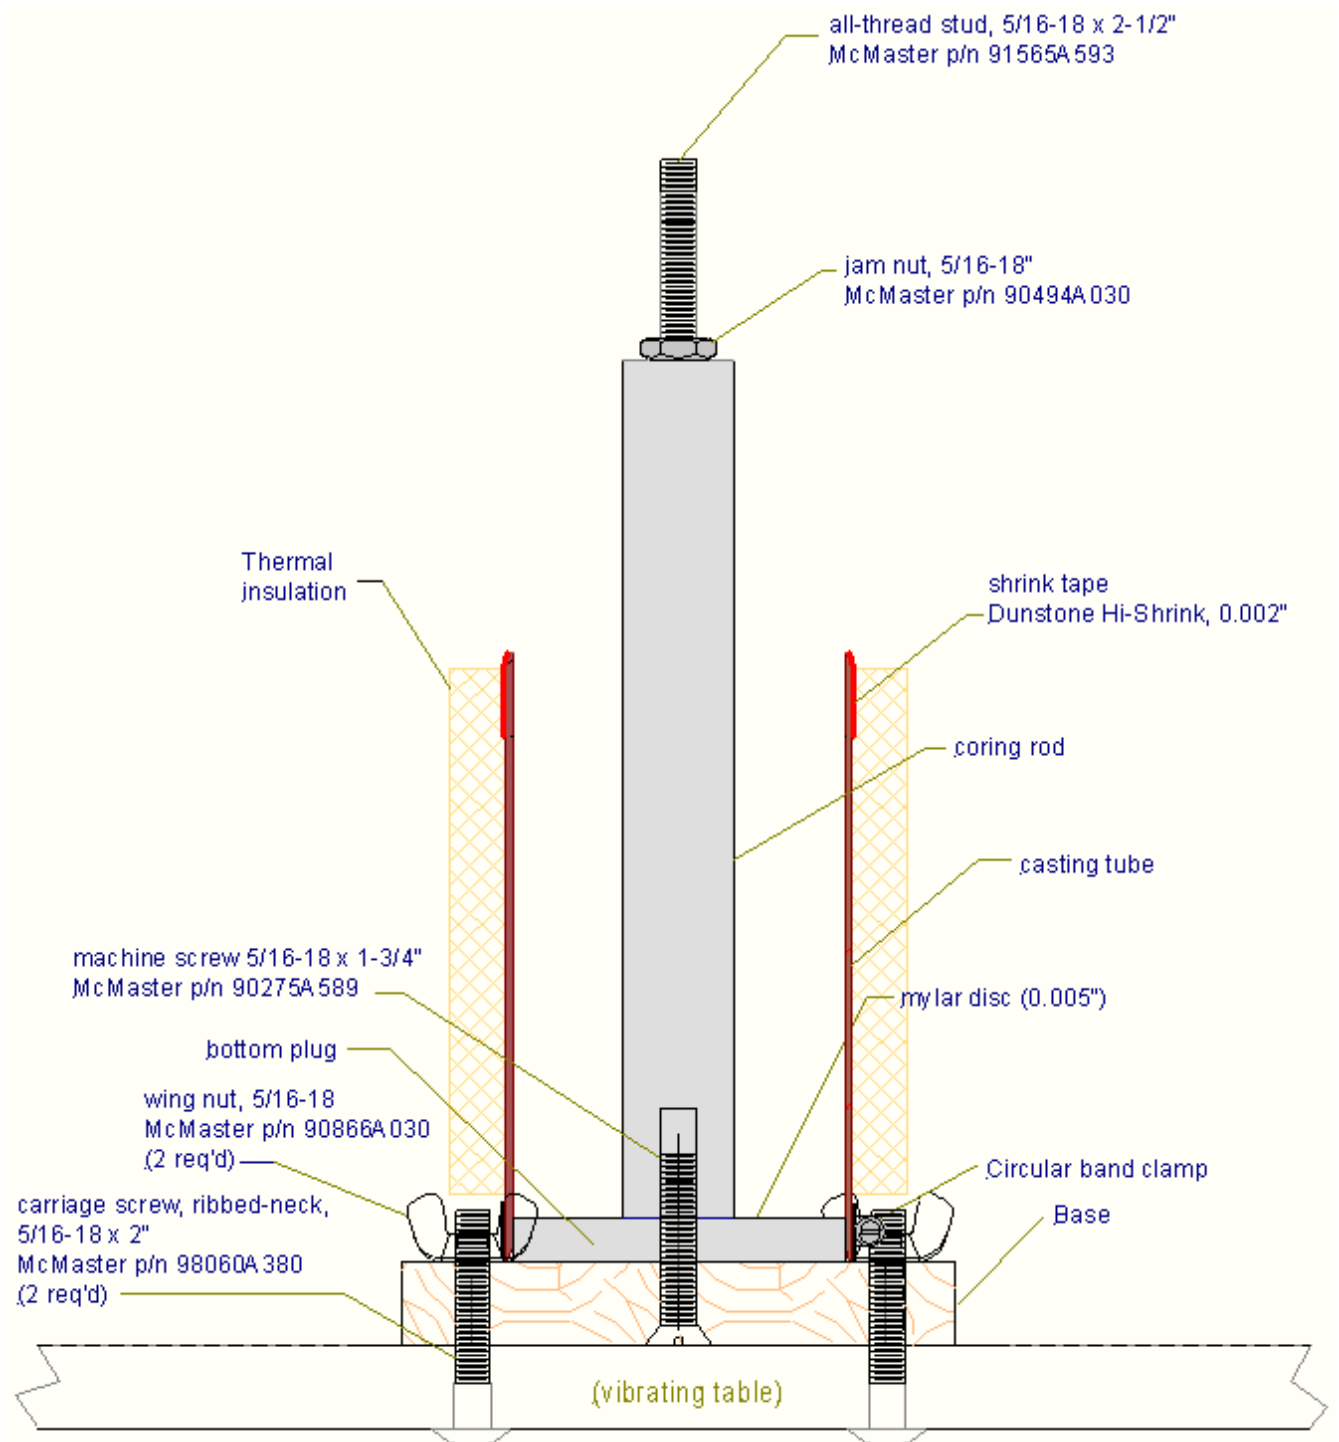
Figure 1 – Casting apparatus set-up for propellant loading operation.

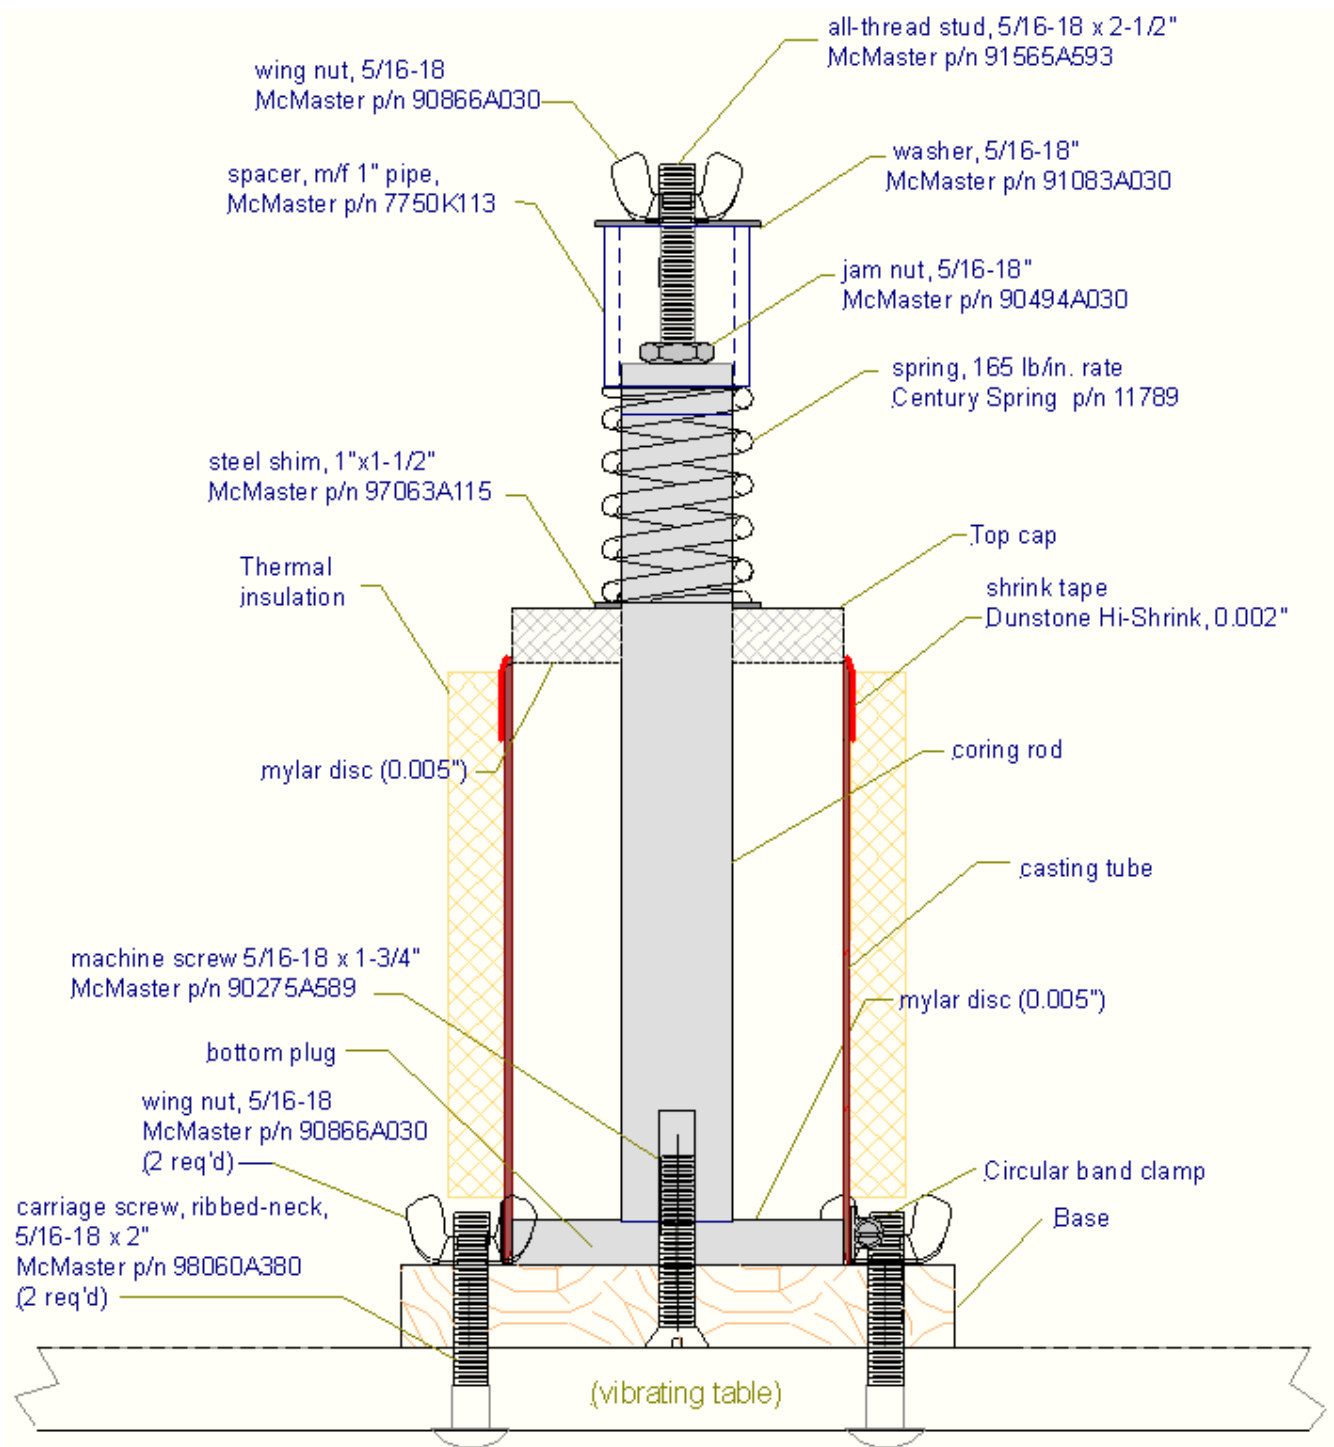
Figure 2 – Casting apparatus set-up for clamping propellant during curing.

Another possible reason for uneven top surfaces is that the clamping pressure may have been insufficient. The springs have a load rating of 165 lbs/inch and when fully compressed, produce a force of 140 lbs. This translates to the propellant being subjected to a hydrostatic pressure of 40 lb/sq.in. Springs with a higher load rating may be beneficial.
